Protection measures against geological failures, during the construction of Thessaloniki - Kavala section of Egnatia Highway in N. Greece

M. Chatziangelou & B. Christaras

Aristotle University of Thessaloniki, mcha@geo.auth.gr, christar@geo.auth.gr

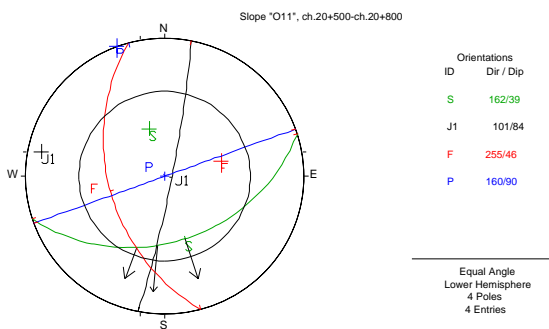
Figure 2. Potential sliding along the slope "O11"

The lake deposits may slide along the direction of the bedding 162/39. Two potential wedges were formed by; i) bedding 162/39 and fault 255/46 and ii) joints 101/84 and bedding 162/39. The sliding took place at SSW direction (Fig.2). Also, the critical slip cycle was estimated using slope geometry of 15m high and slope inclination of 90°. The radius of the critical circle was estimated 15m and the safety factor was calculated 3, for saturated conditions.

In order to protect the slope against sliding, a slope inclination of 34° was proposed. Using the proposed inclination, the radius of the critical circle was estimated at 29m and the safety factor was calculated 5 in saturated conditions.

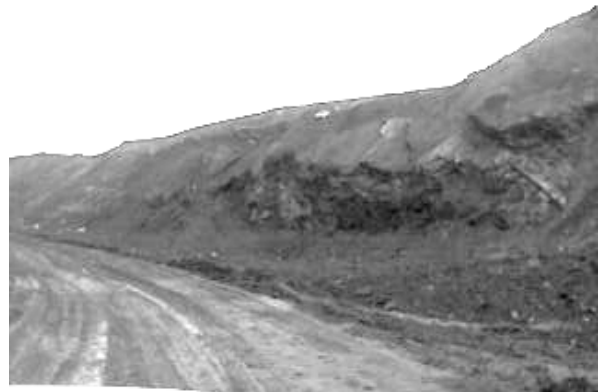
The slope is placed on the right hand of the road and consists of weathered gneiss with pegmatitic intercalations (Fig.3). The poor quality of the rock mass, together with the unfavorable orientation of the schistosity, affected the stability of the slope and caused extensive sliding.

Figure 3. Slope placed on the right hand of the road

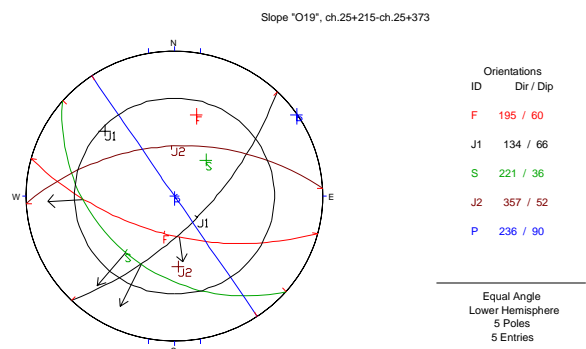
According to *test Markland, 1972*, the schistosity of the gneiss with direction of 221/36 was parallel to the strike of the slope causing planar sliding conditions. Two approaches were considered, in order to protect the slope from sliding (Fig.4).

Figure 4. Potential sliding along the slope "O19"

- i. Change of the slope inclination, or
- ii. Change of the highway direction.

Considering that the second solution was almost impossible, the slope geometry was studied using the limited inclination in order to ensure the stability without changing the road design. Using an inclination more than 36°, ex. 45° (1:1), we could not protect the slope from sliding. This was because the plunge of the schistosity was located inside the area, which was bounded from the slope plane and a friction angle equal to 21°. So, if the average inclination would be less than 34°, the safety was ensured.

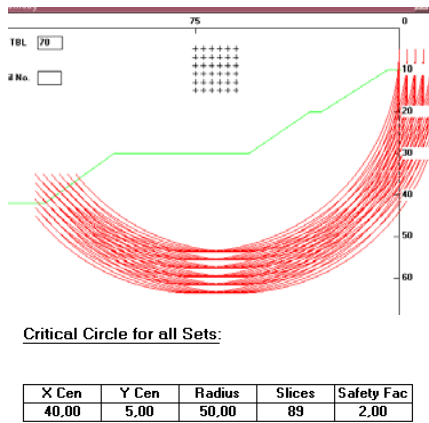
Figure 5. Circle sliding analysis and safety factor of slope "O19" after the embankment's construction, in unsaturated conditions

After the construction of the embankment, the safety factor, in dry conditions, was estimated equal to 2 and in saturated conditions equal to 1 (instability).

Two benches, 10m high were proposed, with inclination of 34° ($V : H = 2:3$). Low vertical benches, having width equal to 5m and height of 2,5m – 3,25m, designed to be created at the site of the embankment, so as the friction between the embankment and the slope to be increased. Using the geometry above, the slope in study was stable in dry conditions ($S.F. = 2$) and almost was unstable (or limited stable) in saturated conditions ($S.F.=1$) (Fig.5,6).

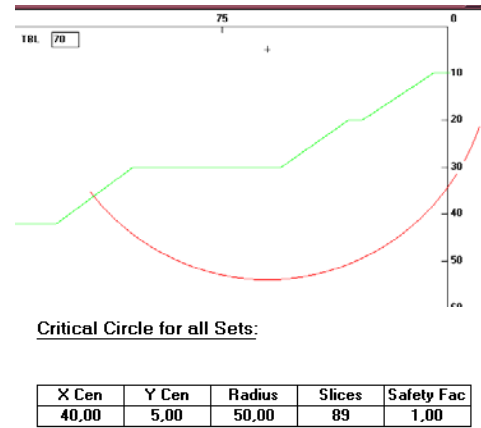
Figure 6. Critical slip circle and safety factor of slope "O19" after the embankment's construction, in saturated conditions

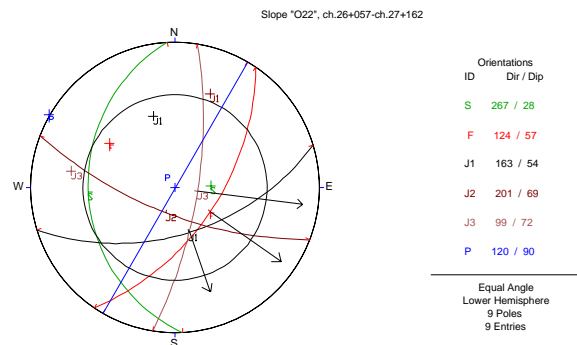
Figure 7. Possible sliding along the slope "O22"

rock mass slipped along; i) the fault 124/57 and ii) the joints of 99/72. Potential wedges were also formed by joints 201/69, 99/72 and joints 124/57 parallel to fault. Sliding took place at SSE direction.

$\phi=26^\circ$, $c=0$), there was a potential cycled sliding (Fig.7). But according to slope stability analysis in saturated conditions, the slope was stable as the calculated safety factor of the critic circle was 7.

Terraces inclined at 45° were proposed to form the "O22" slope in order to be protected from planar sliding. The maximum height of the slope was about 50m. Taking into account that the slope consists of totally weathered gneiss ($\gamma=2,65 \text{ gr/cm}^3$,

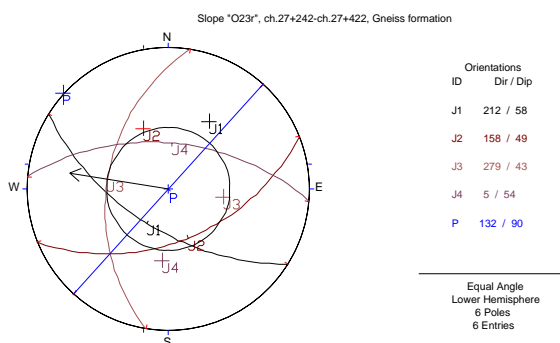
Figure 8. Possible sliding on gneiss at slope "O23r"

According to stability analysis of the "O23r" slope, the type of probable sliding was; i) a planar sliding of gneiss rock mass along the joints

directed to 279/43 and ii) a potential wedge sliding at west direction. The planes of joints 212/58 and 279/43 formed the wedge (Fig.8). The marble rock mass sliced along the joints of 287/71 (Fig.9). As the rock mass was slightly weathered, there was no possibility of circled sliding.

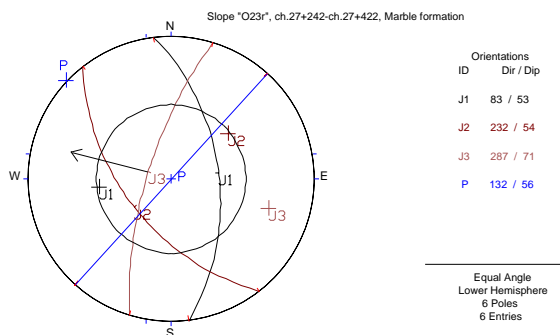
Figure 9. Possible sliding on marble at slope "O23r"

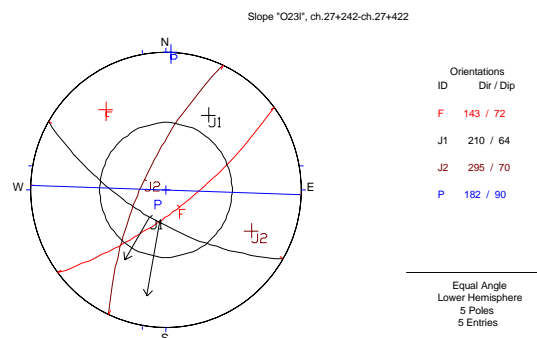
Figure 10. Possible sliding along the slope "O23l"

along the planes of joints 210/64. A potential wedge, being formed by the joints of 210/64 and joints parallel to fault 143/72, sliced at South direction (Fig.10). As the rock mass was slightly weathered there was no possibility of circled sliding.

In order to protect the slope, against sliding, an inclination of slope equal to 45° was proposed.

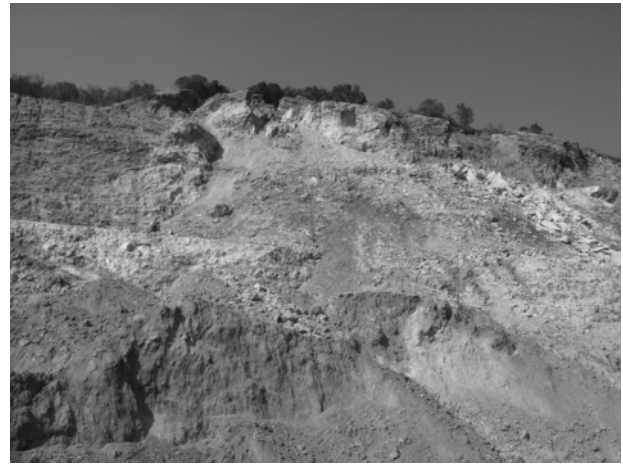
Figure 11. Landslide at ch.9+700 along the road

The slope, 60m high, consists of medium to high weathered, cracked biotitic gneiss. The water of a short rainfall decreased the safety of slope and created landslide. The landslide was bounded at the half-formed part of the slope (Fig.11). Rock mass quality was poor (category IV). Tension

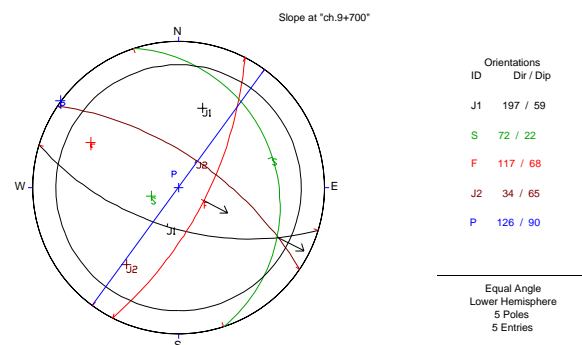
Figure 12. Possible sliding along the slope at "ch.9+700"

crack caused circular soil sliding. The critical circle in unsaturated conditions, was 50m deep and the safety factor was calculated 1,66. In saturate conditions, caused by rainfall, the safety factor was 1,16. A short rainfall, which had taken place on

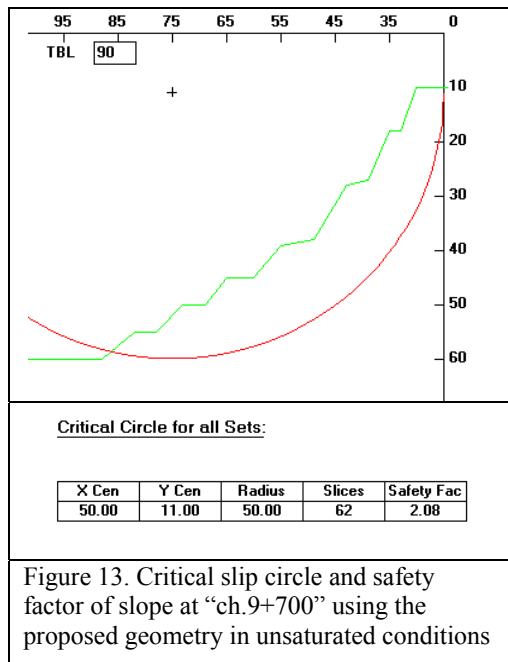
March 2002, created a landslide of the half part of the slope, which was just excavated using a beginning geometry. The slope consisted of small rock blocks. A cyclical sliding of loose material was bounded at east side of slope, where was a fault surface (115/65) and at west side of slope,

where was a long sliding surface (120/76) (Fig12). Rainfall was the main cause of landslide at the safety factor (1,16) in saturated conditions was ultimate (*Chatziangelou & Christaras, 2005*).

For landslide restoration and support, dips of downstairs were proposed to be smaller (height/width=1/1.5 and 1/1) than dips of upstairs (height / width = 2 / 1). Using this new geometry, the safety factor was 25% higher (SF = 2.08) at unsaturated conditions and 35% higher (SF = 1,57) at saturated conditions than using the beginning geometry. The benches of the slope were designed about the same length so as the length did not affect the safety factor and pore pressure. Thus, safety factor depended only on inclination of benches. According to the new geometry, big dips were formed downstairs and small ones were formed upstairs. When the height was also increased, restrained powers were increased and sliding powers were decreased. So, the safety factor of every part was progressively increased downstairs to upstairs making slope stable (Fig.13,14).

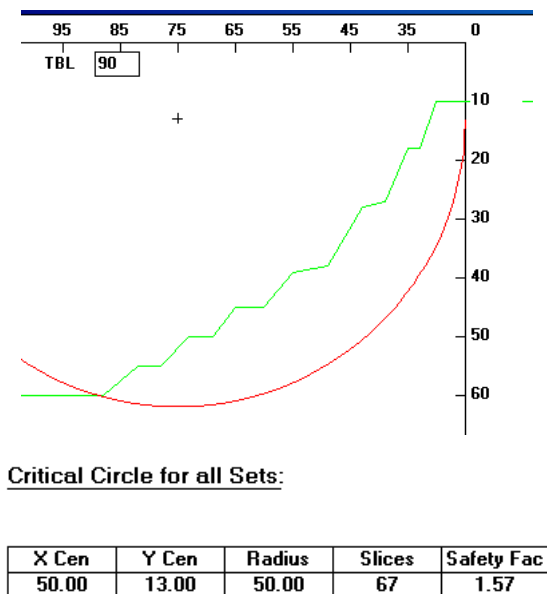
Figure 14. Critical slip circle and safety factor of slope at "ch.9+700" using the beginning geometry in saturated conditions

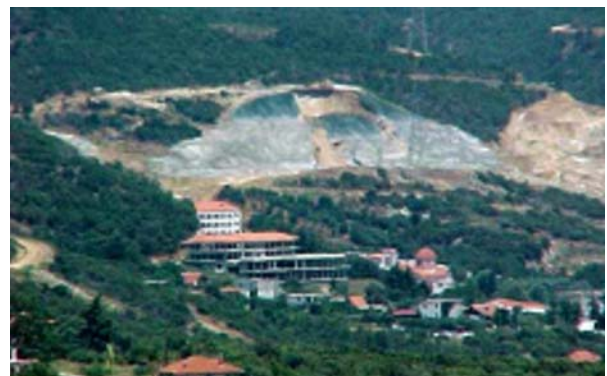
Figure 15. The landslide in study

(4th, 3rd and 2nd) was just completed when an extensive landslide took place. The landslide was placed between ch.10+533 and ch.10+620. The sliding of the trench took place. The sliding of wedge between ch.10+600 and ch.10+620, located in the marble of the 2nd bench, caused the beginning of landslide. The sliding occurred along the schistosity plane 195/39 and joints 278/76. The sliding of the wedge activated new sliding in the neighbor part between ch.10+533 and ch.10+600. The new sliding took place along the direction of gneiss schistosity 213/35. The excavation was interrupted for a long time and a new design of “cover and cut” was chosen to restore the failure (Chatziangelou & Christaras, 2005).

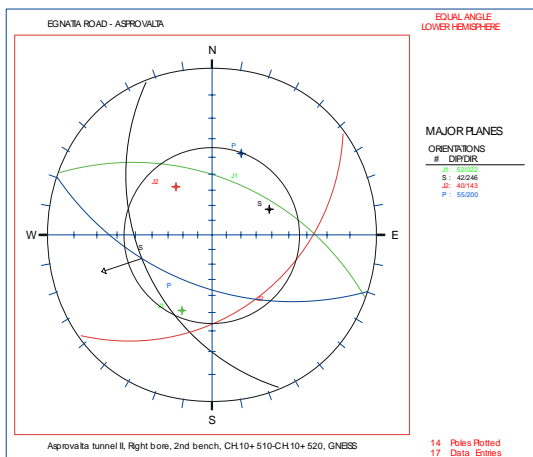
Considering the stability of the slope, gneiss formation, being placed between ch.10+505 and ch.10+556 of the 3rd bench, might slide along the direction of schistosity 213/35. The same formation, being placed between ch.10+510 and ch.10+520 of the 2nd bench, might slide along the direction of schistosity 246/42 (Fig.16). There was a part of completely weathered gneiss, being placed between ch.10+670 and ch.10+680 of the 2nd bench, which might slide along the direction of the section being formed by schistosity 229/48 and joints 169/53 or 125/85. Marble formation, being placed between ch.10+600 and ch.10+640 of the 2nd bench, might slide along the direction of the section being formed by schistosity 195/39 and joints 278/76 (Fig.17, 18).

Figure 16: Potential sliding in gneiss along the 2nd bench, between ch.10+510 and ch.10+520

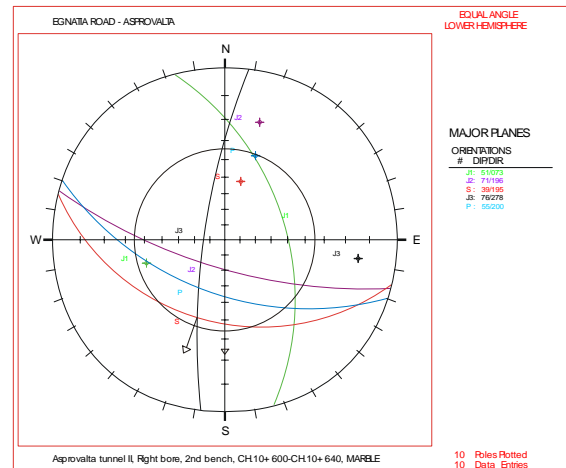
Figure 17. Potential sliding in marble, along the 2nd bench, between ch.10+600 and ch.10+640

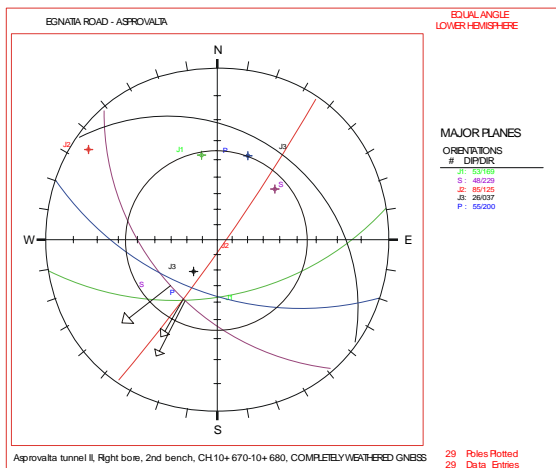
Figure 18. Potential sliding in complete weathered gneiss, along the 2th bench, between ch.10+670 and ch.10+680.
