Deterioration Problems of the Building Materials from Demeter and Asklepios Sanctuaries in the Archaeological Site of Dion, Greece

Papanikolaou E.¹, Spathis P.^{2*}, Melfos V.¹, Christaras B.¹, Pavlidou E.³

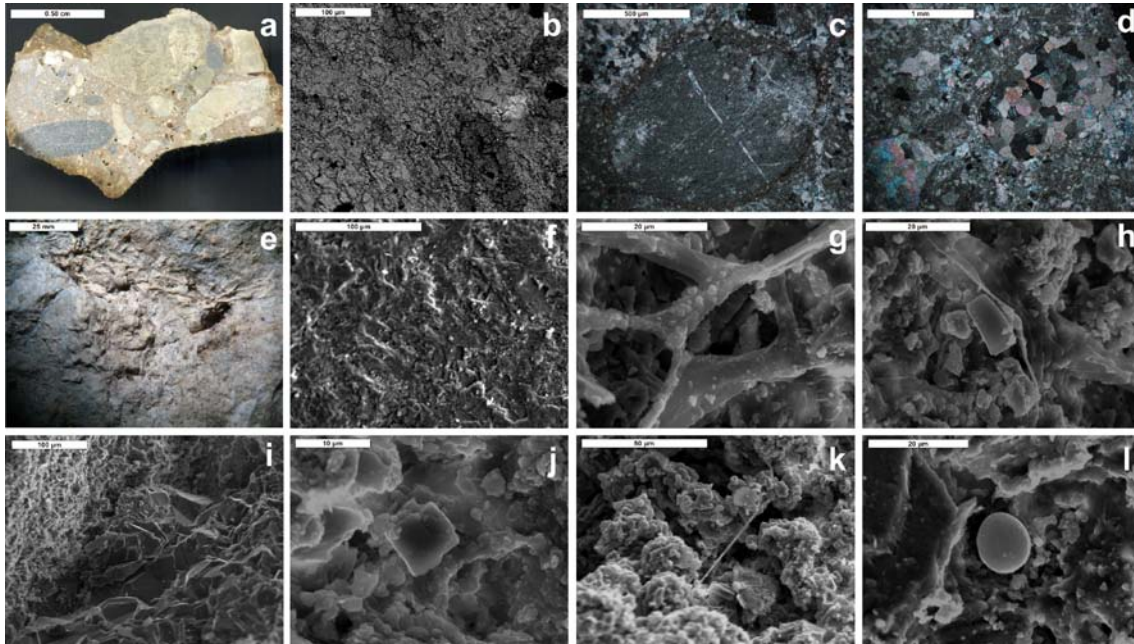
The samples DD2 and DA1 are calcitic conglomerates (Fig. 1) and consist of rounded limestone cobbles which are composed mainly of calcite, with minor dolomite and traces of white mica, quartz and fragments of fossils. Kaolinite, gypsum, illite, dolomite, Fe oxides, chromite and organic matter were detected on the deteriorated surfaces.

Fig.1. Photomicrographs of calcitic conglomerate (DD2 and DA1 samples). a-d: primary mineralogical composition. a) cross-section, b) general view of the surface, dark=dolomite, light=calcite, SEM, c) A cobble of fine-grained limestone in medium-grained dolomite-calcite, optical microscopy, d) A cobble of coarse-grained limestone in medium-grained dolomite-calcite, optical microscopy. e-l: secondary mineralogical composition of the deteriorated surface. e) surface, stereomicroscope, f) general view, g) Secondary carbonate (calcite-dolomite) precipitated from water solutions, SEM, h) secondary calcite-dolomite crystals, SEM, i) recrystallized calcite-dolomite crystals, SEM, j) gypsum crystal, SEM, k) illite and calcite-dolomite crystals and an organic fiber, SEM, l) An organism, SEM

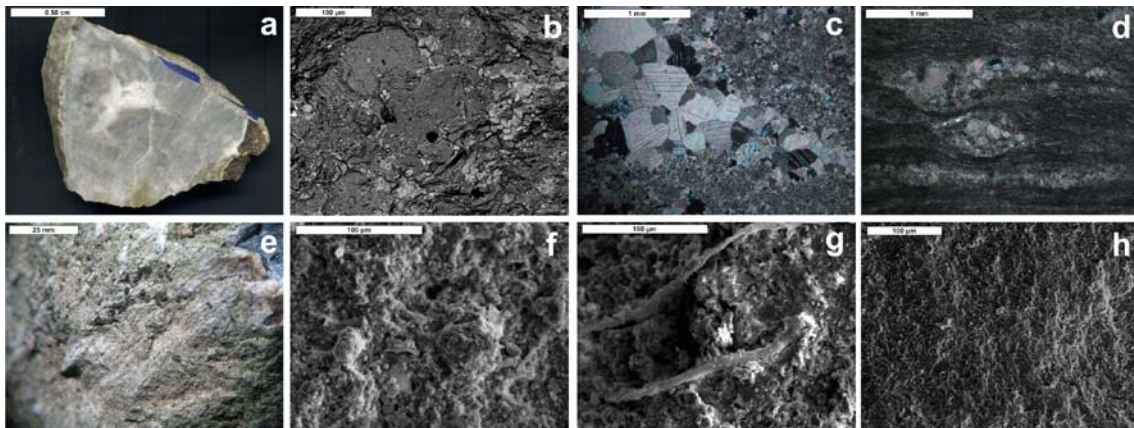
The samples DD3 and DA2 are dolomitic limestones displaying a characteristic layering (Fig. 2 and 5). The mineralogical composition of the limestones is dolomite with traces of calcite, aragonite, quartz, white mica or albite. White mica, illite, albite, rutile, Fe-oxides, dolomite, quartz and hematite were found on the deteriorated surfaces.

Fig. 2. Photomicrographs of dolomitic limestone (DD3 and DA2 samples). a-d: primary mineralogical composition. a) cross-section, dark=fine-grained dolomite, light= coarse-grained dolomite, b) Dolomite (dark) and calcite (light) crystals on the surface, SEM, c) Coarse-grained and fine-grained dolomite-calcite, optical microscopy, d) Coarse-grained dolomite lenses in fine-grained dolomite-calcite, optical microscopy. e-i: secondary mineralogical composition of the deteriorated surface. e) surface, stereomicroscope, f) Secondary dolomite-calcite, SEM, g) and h) Carbonate (dolomite-calcite) precipitated from water solutions, SEM, i) Secondary dolomite and illite precipitated on the surface, SEM

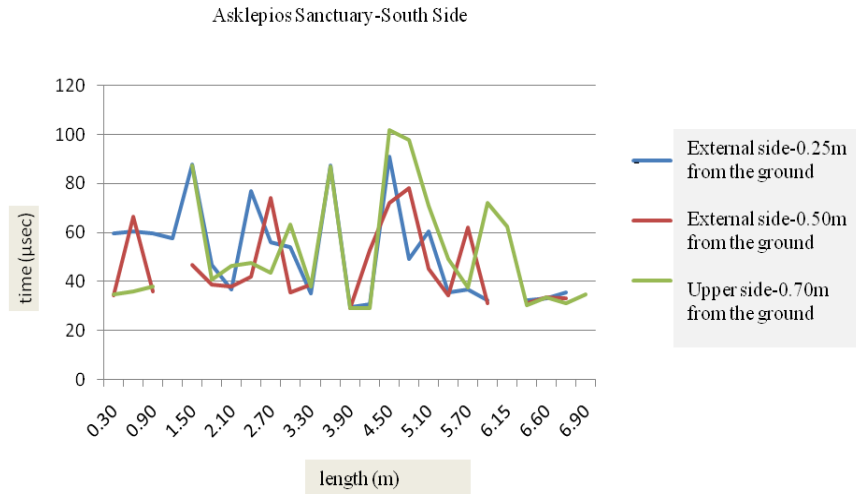
Fig. 6. Ultrasonic velocity measurements, travel time vs length (horizontal axis), on the surfaces of the external or the upper side of the plinths of the south wall of the temple of Asklepios sanctuary.

From the results of ultrasonic velocity measurements (Fig. 6) and the examination of the possible influence of the orientation on the weathering degree of the materials we concluded that the travel times were not depended on the distance from the ground level and on the orientation of the walls. However, great differences and fluctuations of the measured time values along the horizontal axis were observed. This fact is probably due to the nature of the measured materials. The building materials of the walls of the temple of Asklepios sanctuary consist mainly of conglomerate and limestone, which are relatively porous materials with an anomalous and not stable structure. This suggestion was confirmed by the ultrasonic measurements that were carried out on the marble base of a statue of priestess Verenike, sited in the area of Demeter sanctuary. The measured times on the marble surface were very similar, with no fluctuations and the observed values (22-25 µsec) were obviously lower than the observed values on conglomerate and limestone (30-120 µsec), indicating greater ultrasonic velocities and so more stable and less weathered material.

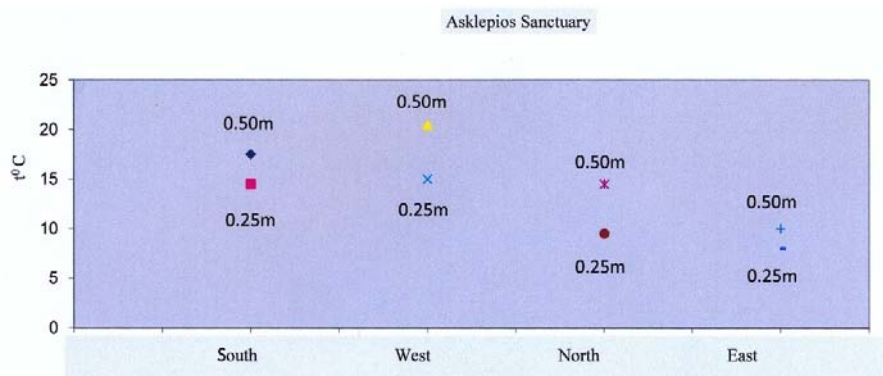
The results of the infrared thermographic insitu measurements are shown in Fig. 7, where the recorded temperatures on the surfaces of the walls of the temple of Asklepios sanctuary and in various distances from the ground are also presented. The observed temperature variations indicated the presence of water within the stones.

Fig. 7. Temperatures recorded on the surfaces of the walls of the temple of Asklepios sanctuary and in various distances from the ground.

moisture (water movement) in porous material; it monitors the water movement in porous materials and detects its impact by recording temperature variations on the stones' surfaces. The presence of moisture (lower temperatures) that arises as a result of the capillary movement of water has caused deterioration of the building material. This is mainly because during water movement inside the pores there is also movement of salts. Since such porous materials have high porosity values and large amounts of large pores that trigger capillary action, water movement inside their porous systems occurs. In such cases, the optical properties are altered, the density, specific heat capacity and thermal conductivity are also affected and so any temperature changes are much slower in a moist area, as the energy required to raise the temperature of a moist area would be much greater than an area that is unaffected by water.
