ESTIMATION OF THE STABILITY OF A MARLY SLOPE, AFTER RAINING. THE CASE OF KAPSALI AREA, IN KITHIRA ISLAND

By: B. CHRISTARAS¹, M. ARGYRIADIS² & E. MORAITI³

In April 2004, the southern part of Kithira Island, in the uphill area of the touristic Kapsali Golf, consisting of marl and overlain by limestone, was affected by a large scale landslide, divided in two parts. This landslide destroyed the road Kapsali – Kalamos.

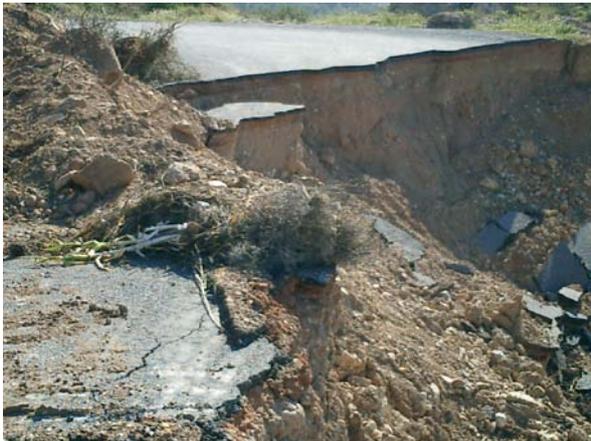
Fig. 4. The crest of the eastern sliding “Slide 2”

This slide occurs two sliding parts. The crest of the upper sub-sliding is located at a height of 70m (Fig. 1, 4, 7) while its toe daylights at a height of 64m (Figs. 1, 7). The crest of the lower sub-sliding is located at a height of 55m while the toe daylights at a height of 44m, not far from the houses (Fig. 1, 8). The sliding covers an area of about 3000m² with a width of 45m. The sliding was activated toward S-SW direction. The vertical slip, at the crest of the sliding was 5m.

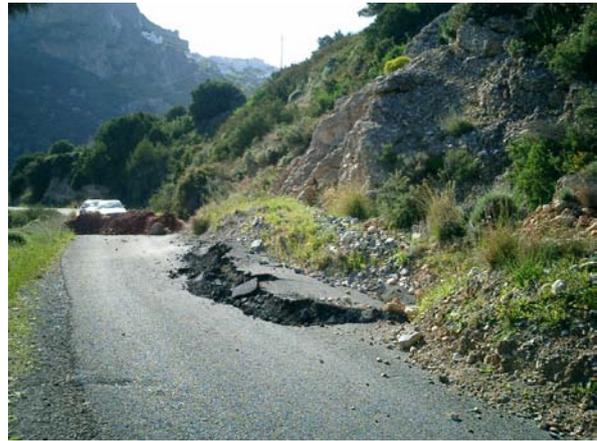
Fig. 5. The toe of the western sliding “Slide 1”

in the marl and affects the road to Kapsali Village (Figs. 4). In Fig. 5, the toe of the western sliding (slide 2) is presented.

The crest of the landslide is located at a height of 71m (Fig. 1, 6) while the toe is located at a height of 62m (Figs. 1, 5, 6). The sliding is circular with W-SW direction. This rotational movement created a failure of 2,5m high and an horizontal opening of 0,5-1,5m. For estimating the cohesion (c) and the internal friction (ϕ) of the marl and performing the slope stability analysis, we used the back analysis technique, for saturated conditions, which are similar to the raining conditions of the sliding time. So, we arrived to the following data: $c=4\text{kN/m}^2$ and $\phi=18^{\circ}$, for the given landslide geometry and safety factor $SF=0,993$.

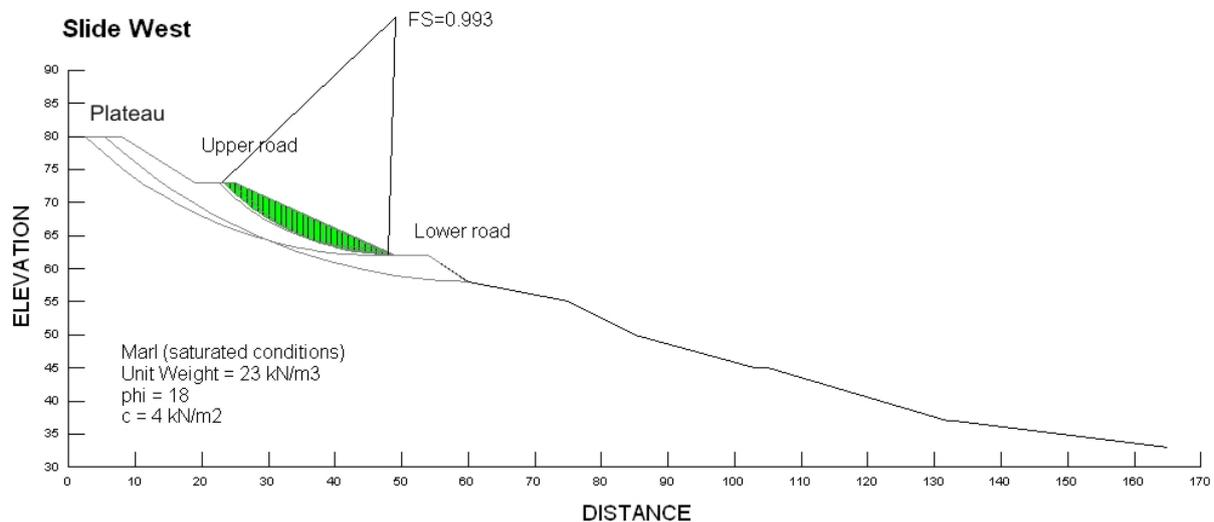
Fig. 6. Slope stability analysis of "Slide 1" using back analysis technique

The above used values were also verified in the Eastern Slide. It is interesting to mention that several possible sliding circles are given in Fig. 6 but this which is used refers to the slide occurred, living possible the occurrence of a bigger sliding if the slope is not protected.

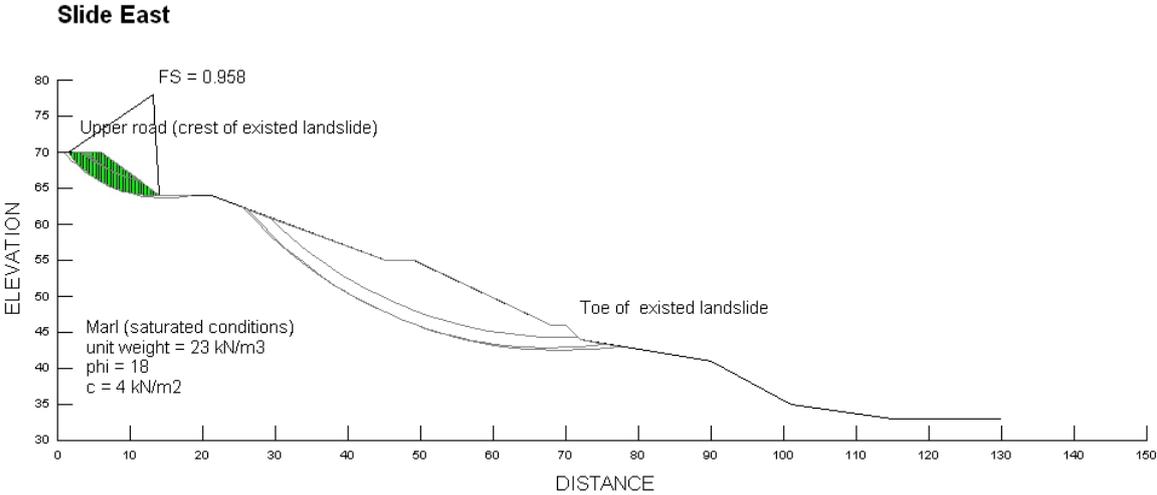
Fig. 7. Slope stability analysis at the upper part of the eastern slide (slide 2), using back analysis technique

For similar reasons as for slide 1, we arrived to the following data: $c=4\text{kN/m}^2$ and $\phi=18^\circ$ and safety factor $SF=0,958$, for the upper sub-slide and $SF=0,996$ for the lower sub-slide.

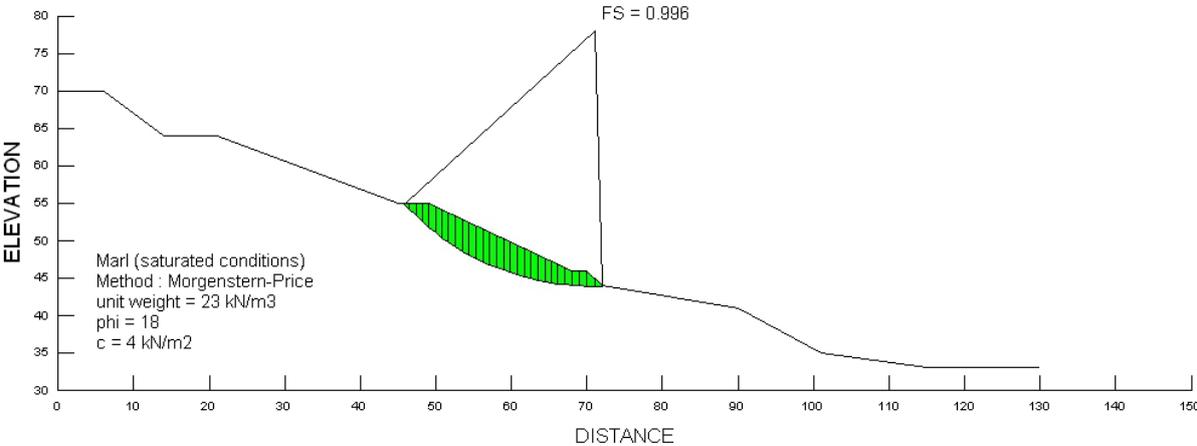
Fig. 8. Slope stability analysis at the lower part of the eastern slide (slide 2), using back analysis technique

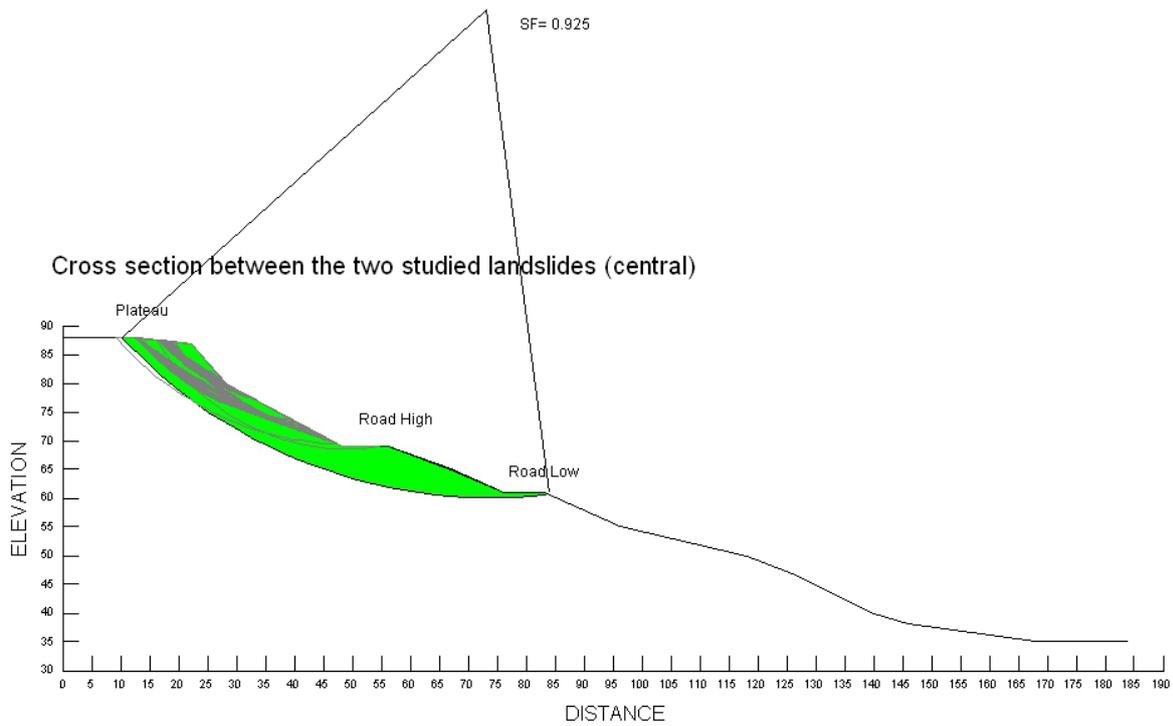
The results of above slope stability tests were used for analyzing the slope stability along the neighbor cross-sections A1-A2 (Figs. 1, 9) and B1-B2 (Figs. 1, 10).

According to our elaboration, the sliding circles give safety factors A1-A2: $SF=0,926$ (Fig. 9) and B1-B2: $SF=0,66$ (Fig. 10).

Fig. 9. Slope stability analysis along the axis: A1-A2, using back analysis data

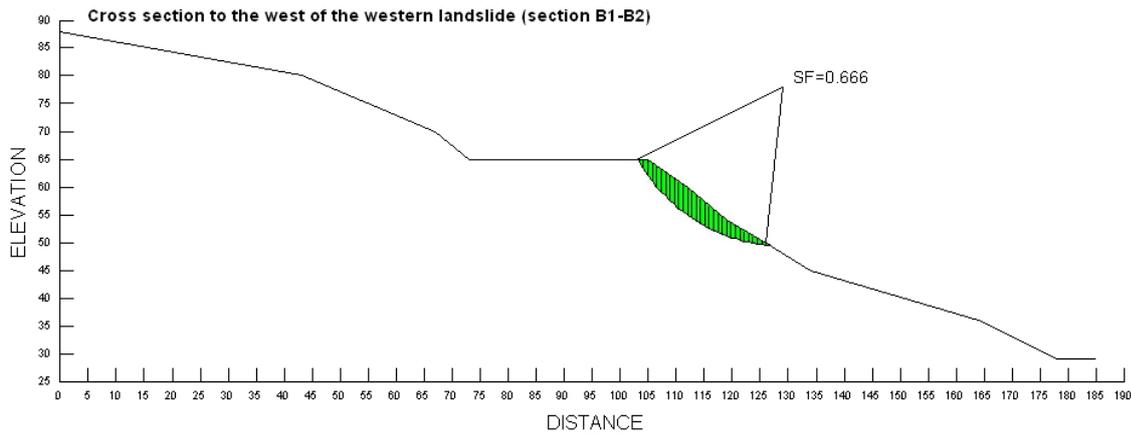
Fig. 10. Slope stability analysis along the axis: B1-B2, using back analysis data
