# Structural Repair and Maintenance of Historical Buildings III

**Stability and materials weathering  
conditions at the Symonos Petra Monastery  
of Mount Athos, Greece. Preliminary  
approach**

# Stability and materials weathering conditions at the Symonos Petra Monastery of Mount Athos, Greece. Preliminary approach

B. Christaras,<sup>a</sup> A. Moropoulou,<sup>b</sup> A. Dimitriou,<sup>a</sup>  
M. Diamantopoulou,<sup>a</sup> K. Bisbikou,<sup>b</sup> P. Theoulakis<sup>b</sup>

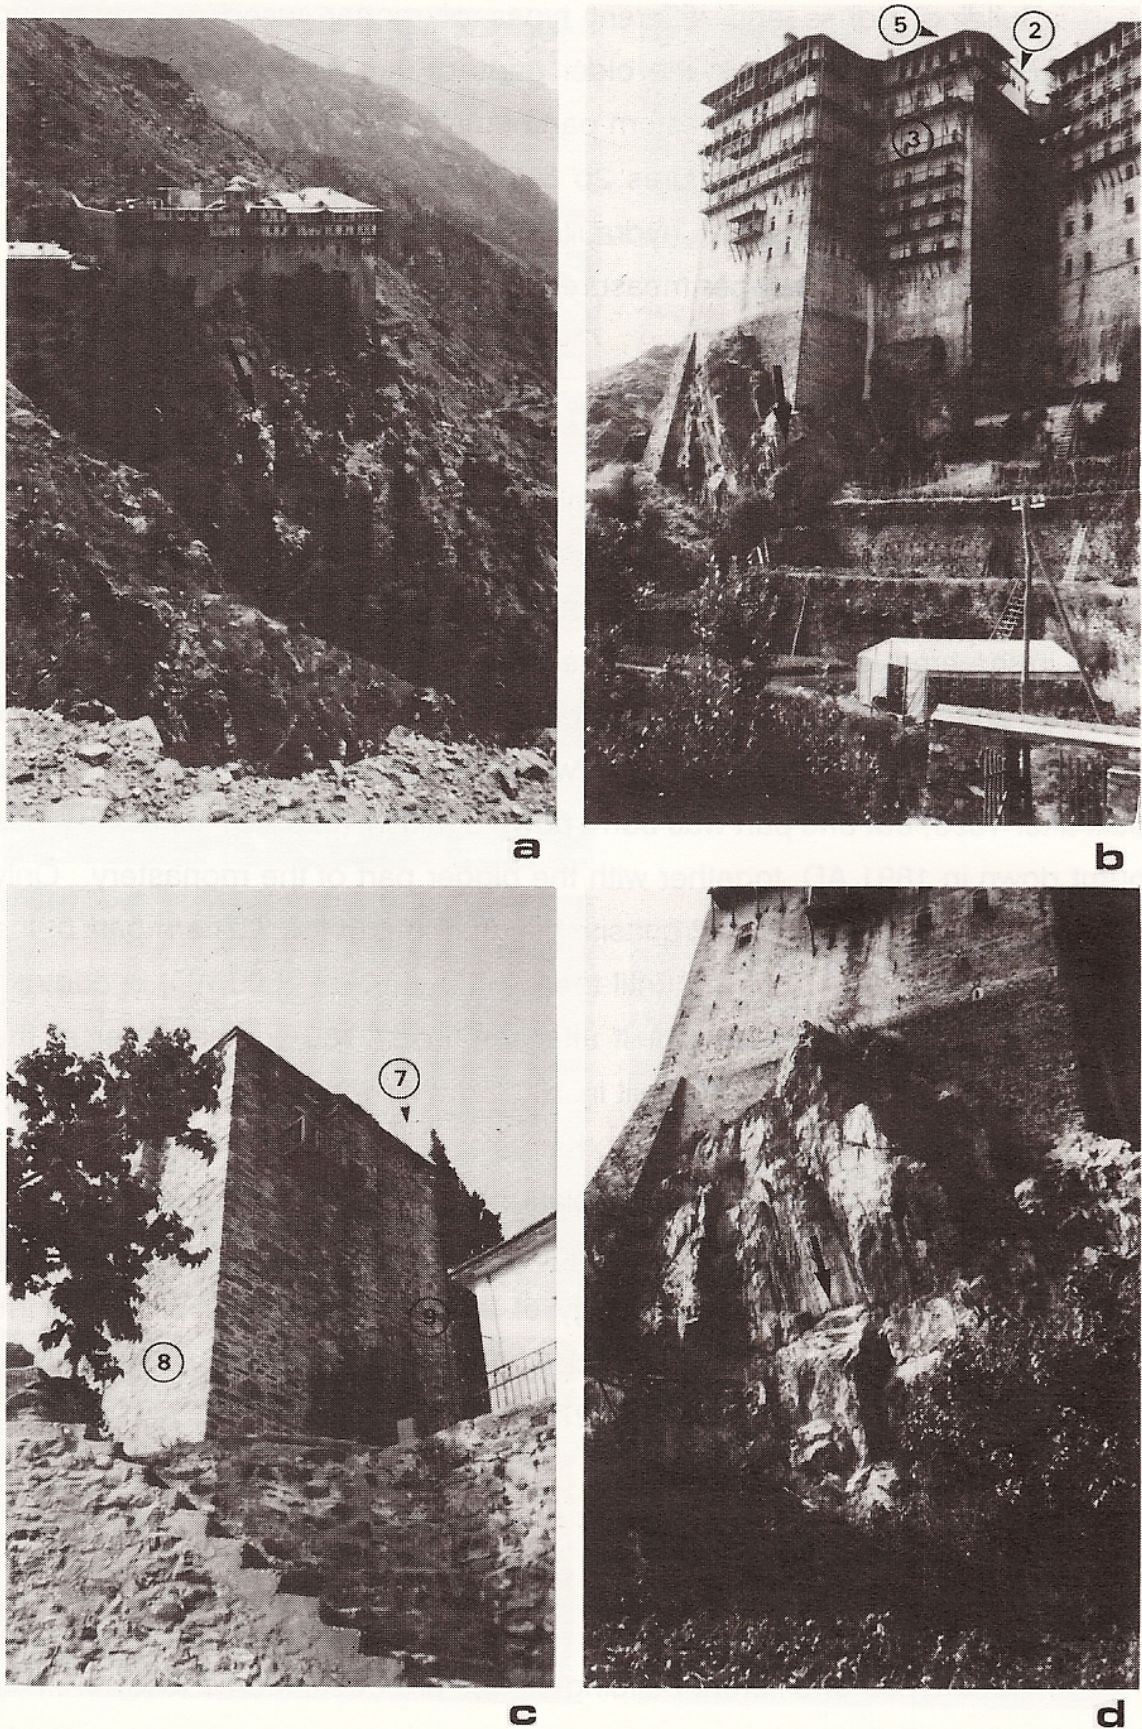
**Figure 2.** The Monastery. a: Western site - a probable fault (? , F), b: Southern site - important fractures; sites of sampling are also referred, c: Shipyard tower (arsenal) - sites of sampling & d: Southern site - a detail with a fracture.

site E, causing damage to the foundation of the Monastery (Figures 2a, 6E, 8E). No farther investigation has been made yet to determine the nature and the origin of this discontinuity.

At the southern part of the Monastery, joints of SSW or SE dip direction cause probable wedge or planar failures (Figures 2b, 2d, 8J1, 8J2). J1 position is very close to J2. The only difference is that the slope face is nearly vertical at the lower part of the building (J2).

- The rock-hill, where the Monastery is built, is totally fractured.
- An important discontinuity cut the western side of the rock-mass causing damage to the foundation of the Monastery.

- According to our preliminary collected data, the southern slope of the rock-hill presents, relatively, unstable conditions; further research on slope stability analysis lead to more proper preservation measures, which have to be applied.

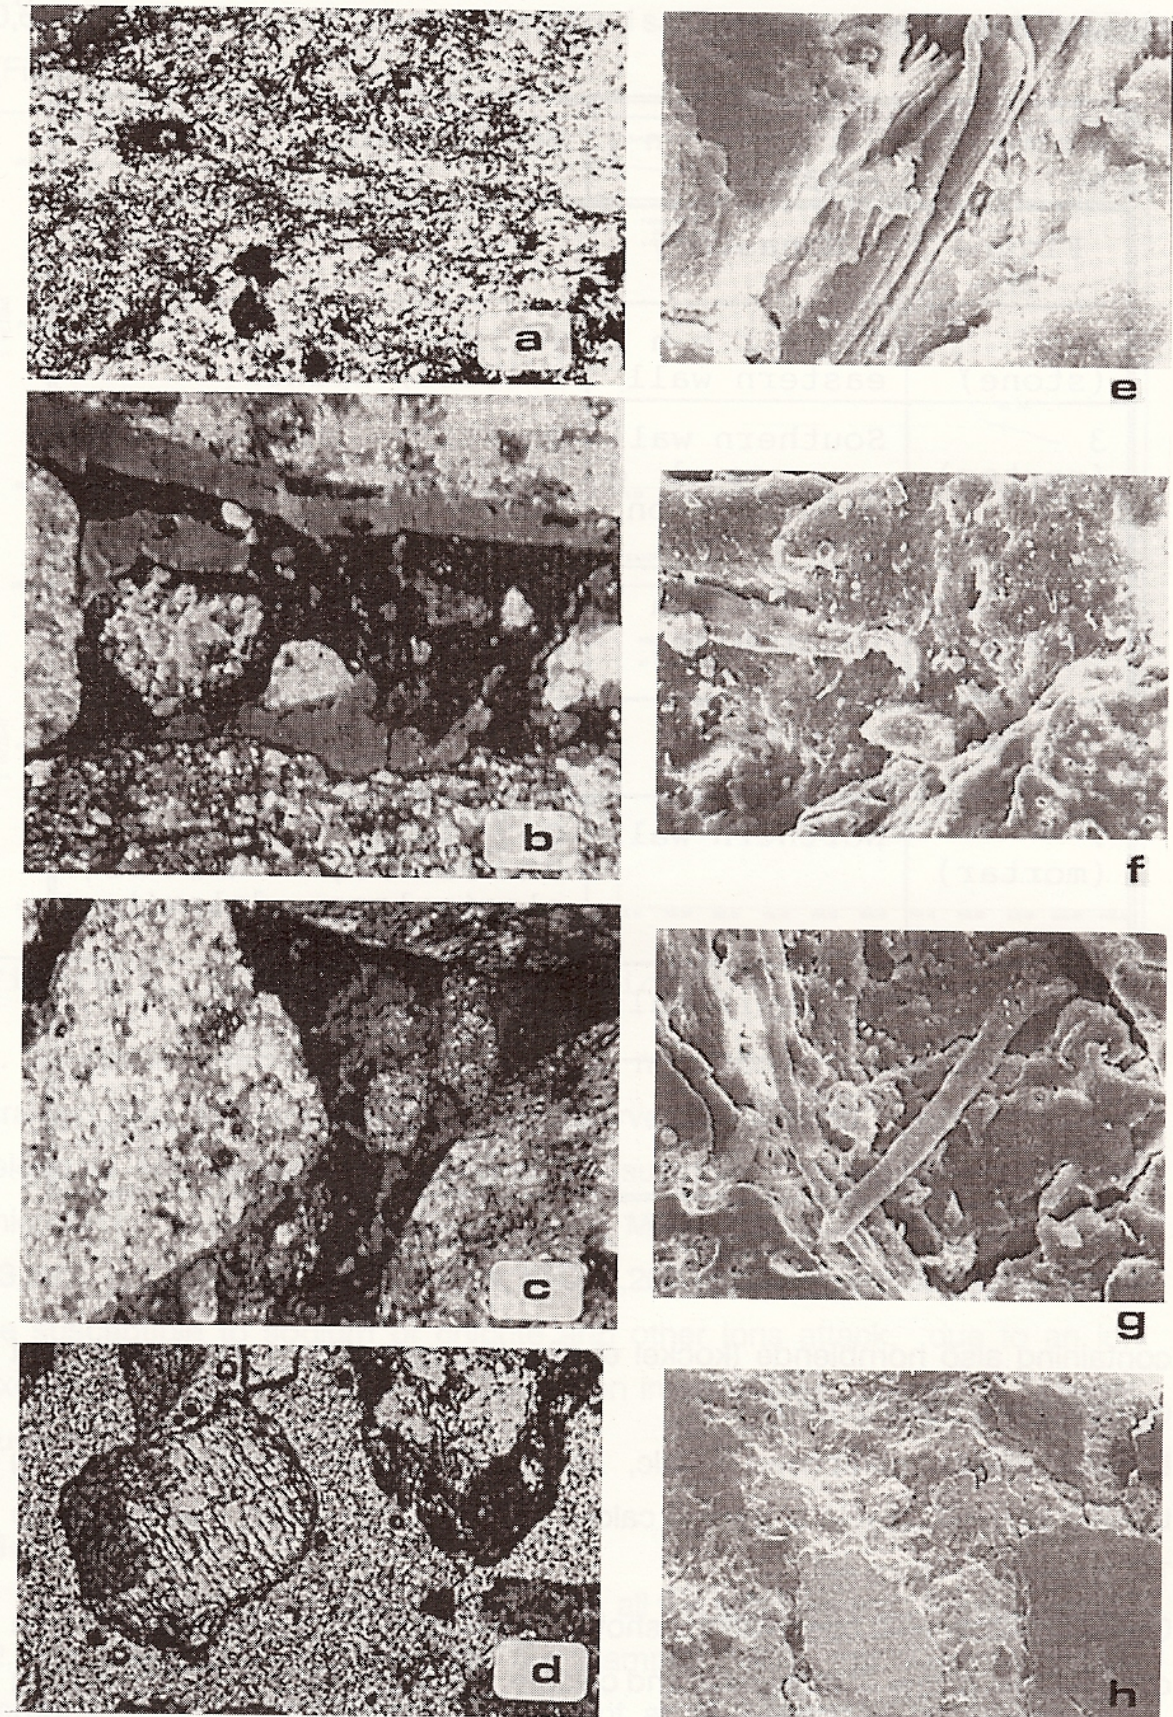
**Figure 3.**Optical microscopy (a,b,c,d) & SEM analysis (e,f,g,h):talc schist a(16x #), e(655x,Mon.-church)-cementitious mortar (b(16x #), f(373x,Arcenal)-cementitious mortar matrix and aggregate c(16x #), g(745x,Arsenal)-degrad.mortar d(16x //), h(46x,Mon.-church)

Optical microscopic observations show (Figure 3a) a finely grained mass with oriented fine grains of muskovite and chlorite. Fe oxide veins are transpassing the mass. A substrate susceptible to serious soluble salts decay problems is indicated. However electron microprobe analysis does not reveal any Cl or S content (MgO: 30,16% ,Al<sub>2</sub>O<sub>3</sub>: 13,35% ,SiO<sub>2</sub>: 45,02% ,CaO:0,70% ,Cr<sub>2</sub>O<sub>3</sub>:

cementitious mortars to the substrate (fig. 3b), whereas their scanning electron micrograph (fig 3f) seems to be similar to these of high pozzolanic content, implying hydraulic character (Lewin,1981). The rounded shape of the aggregates (fig 3c) in comparison with the angular ones of the Monastery decayed mortars (fig 3d) is supporting the above conclusion.

Even though calcite crystals elongate within the pores of the cementitious matrix (Figure 3g), and calcite is identified in all the Arsenal mortars

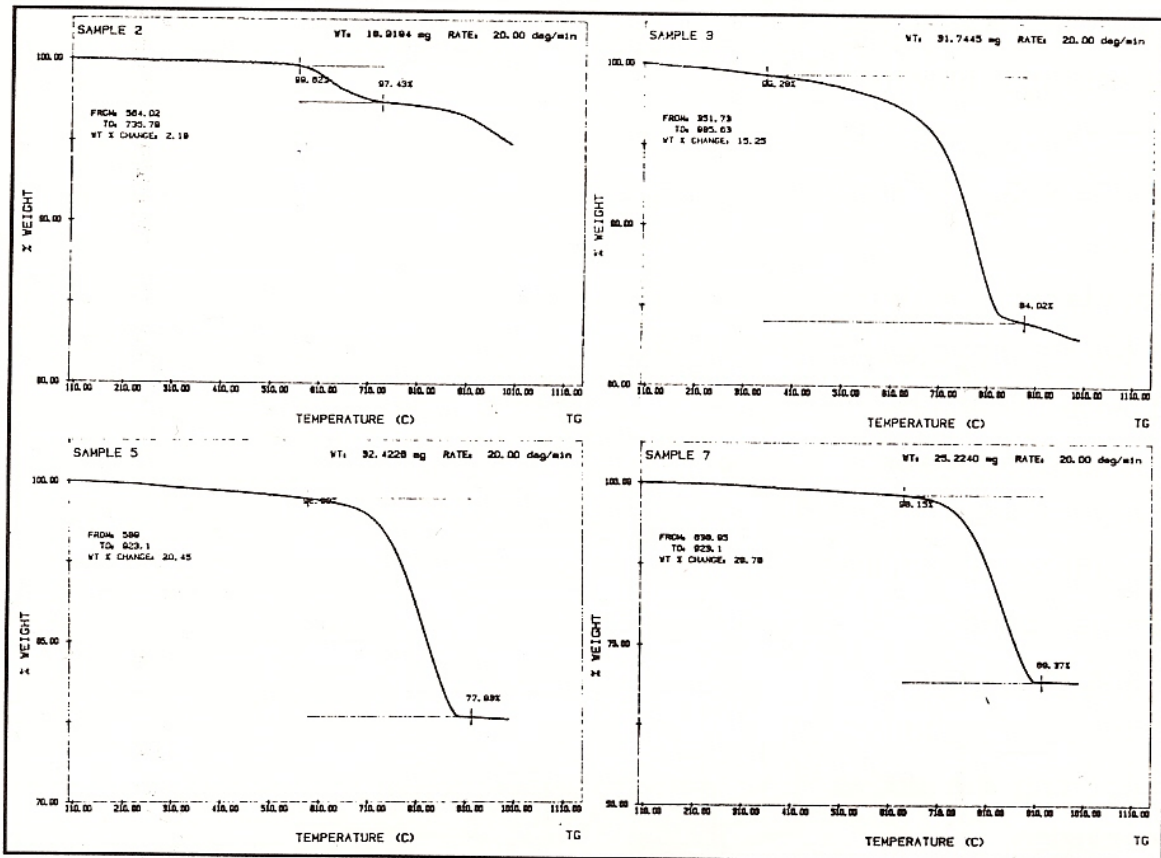
**b. Talc schist**, composed by talc, chlorite, calcite and spinell, according to XRD analysis, (Table I), poor in calcite (content up to 2,18% , according to TG analysis - Figure 4a).

Figure 4. TG (Thermogravimetical) – results.

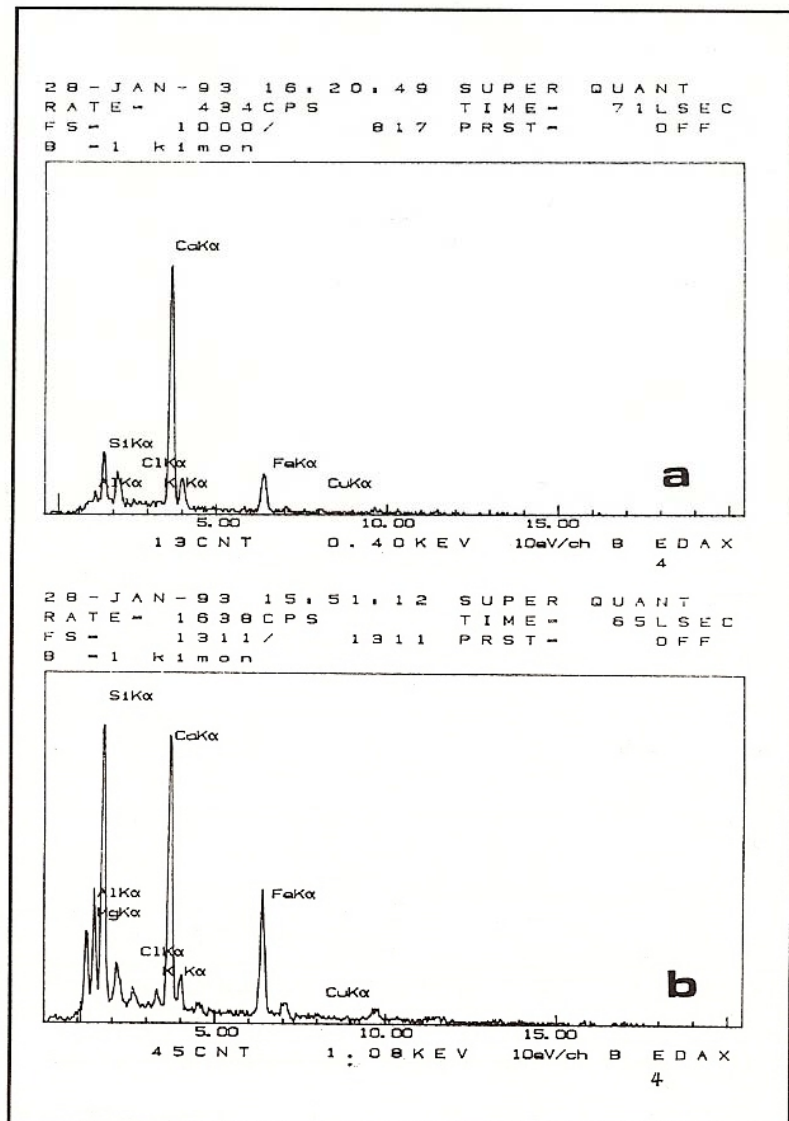
(Table 1 - XRD results), the energy dispersive (EDX) analysis show a low calcitic in contrast to the high Mg-Al-Si contents (MgO : 29,91% , Al<sub>2</sub>O<sub>3</sub> : 7,99% , Si<sub>2</sub>O : 56,12% , CaO : 0,13% , Cr<sub>2</sub>O<sub>3</sub> : 0,30% , Fe<sub>2</sub>O<sub>3</sub> : 6,25% ), as far as cementing material is concerned. Comparing these data to the Monastery mortars (Figures 5), a considerably lower Sika - Alka and higher Caka peak is noticed. TG analysis however indicates considerable weight loss at the 910° C, implying an aluminum- magnesium transformation which for the Arsenal mortars is almost double. Hence, cement mortars with hydraulic character and excellent adhesion to the building stones are not altered by weathering,

**Figure 5.** Energy dispersive analysis (overall results: cementing materials-aggregates) a: Monastery sample No 5, b: Arsenal sample No 8.

even in more intense saline atmospheres, like in the case of the Arsenal, in comparison with the Monastery, whereas the more calcitic mortars of the later are totally decayed.

Main problems present the old calcitic mortars in the case of the Monastery structures, which are even absolutely decayed. On the contrary, old Arsenal mortars, even in more intense saline environment, present an excellent cement behaviour and adhesion to the substrate. Further research on their hydraulic components would be of interest for restoration mortars, which are of need to the Monastery work.

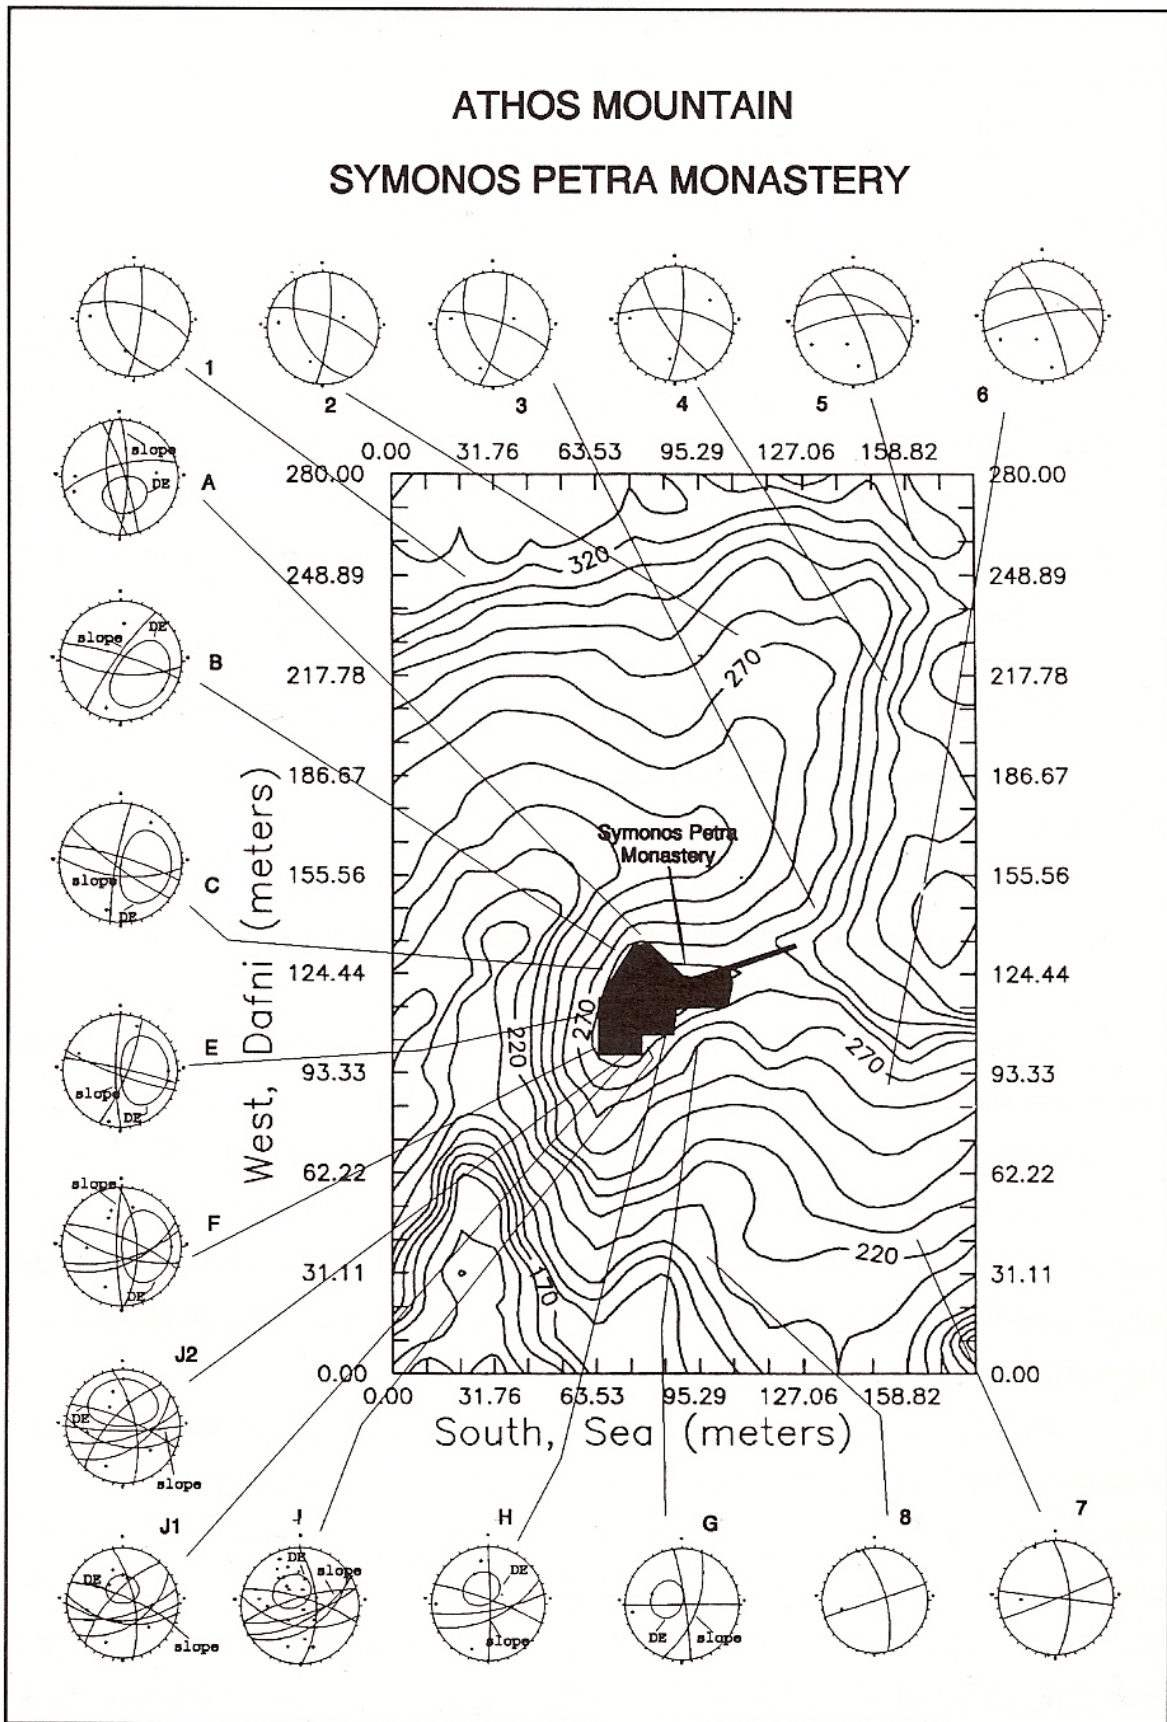
**Figure 6.** Topographic sketch of the Monastery surrounding area, with geotechnical data.

The area is totally fractured and is traversed by joints of various directions. From a first point of view, these joints can cause unstable geotechnical conditions, especially at the slopes of the construction area. The main directions of the joints measured are given in Figure 6.

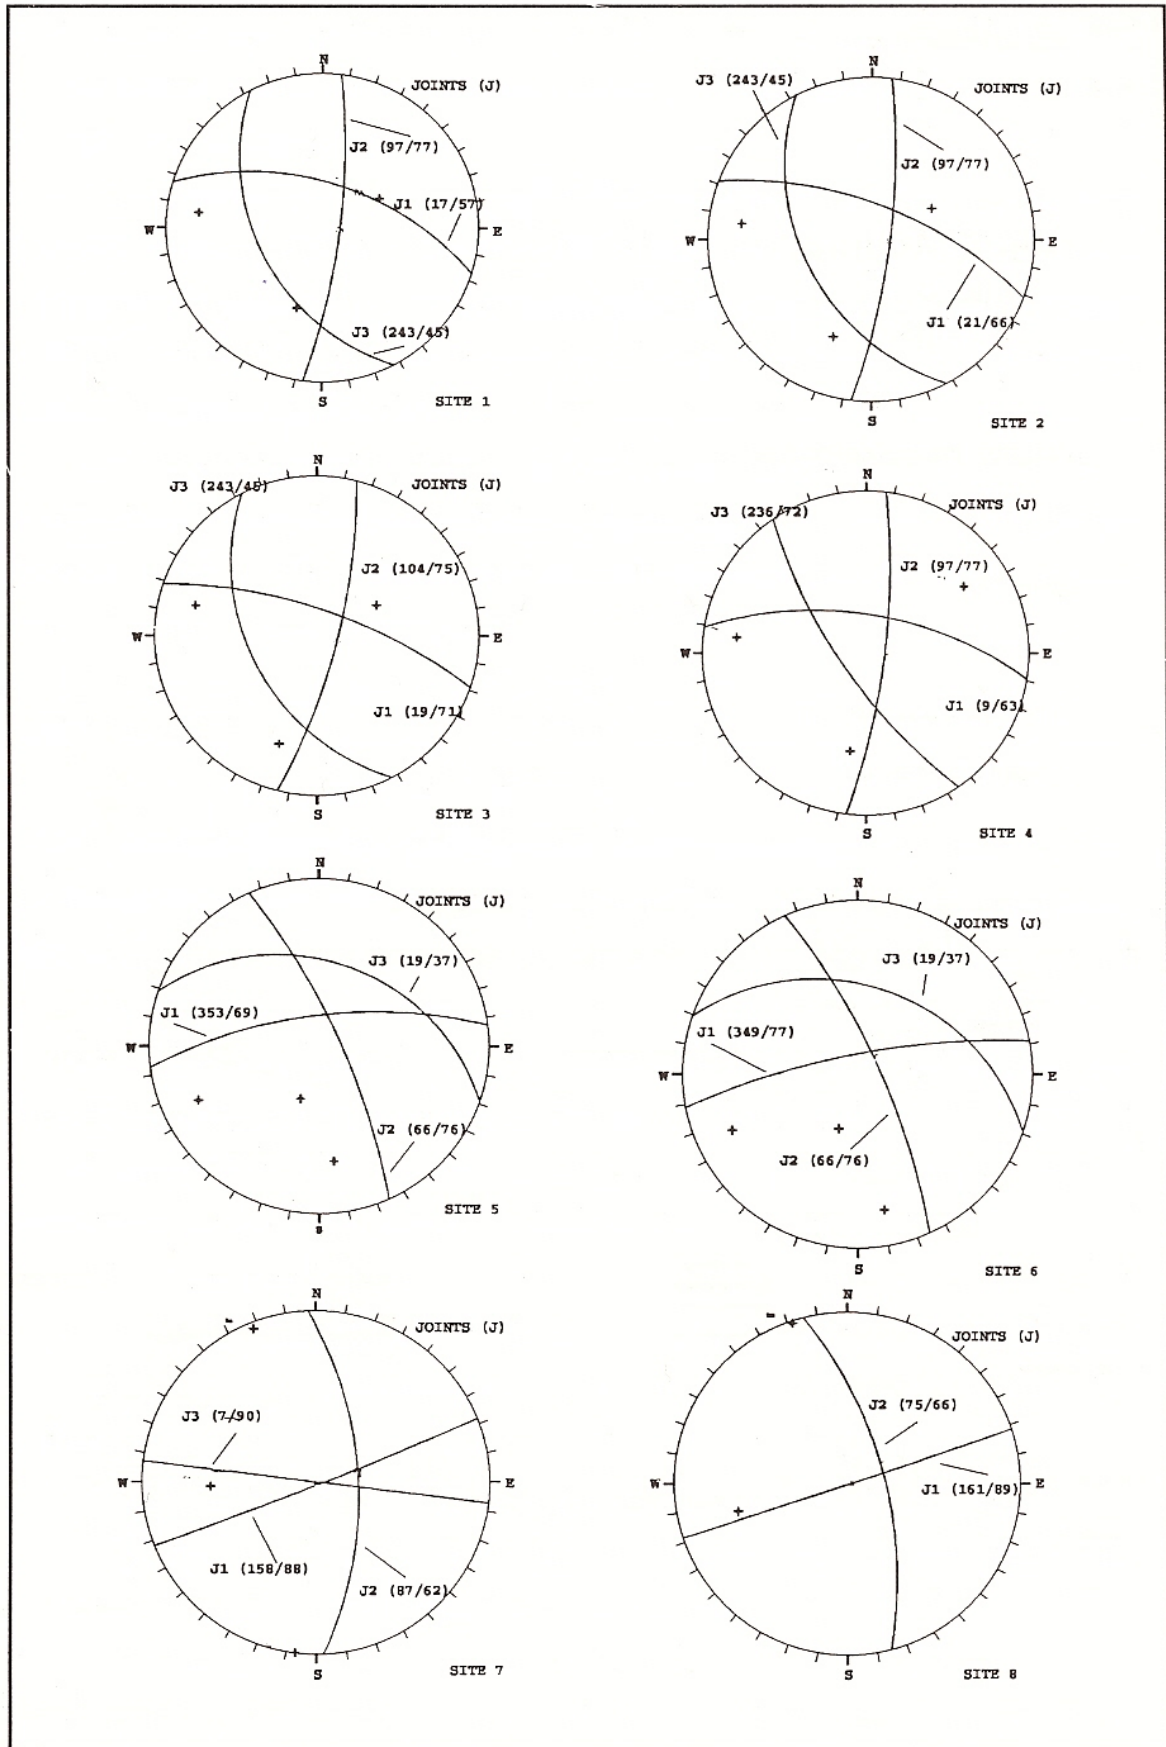
The Joint sets of the surrounding area are given in Figure 7 while those of the rock where the Monastery is built, are given in Figure 8. Their interpretation was made using Schmidt diagrams..

Figure 7. Joint set from the surrounding area.

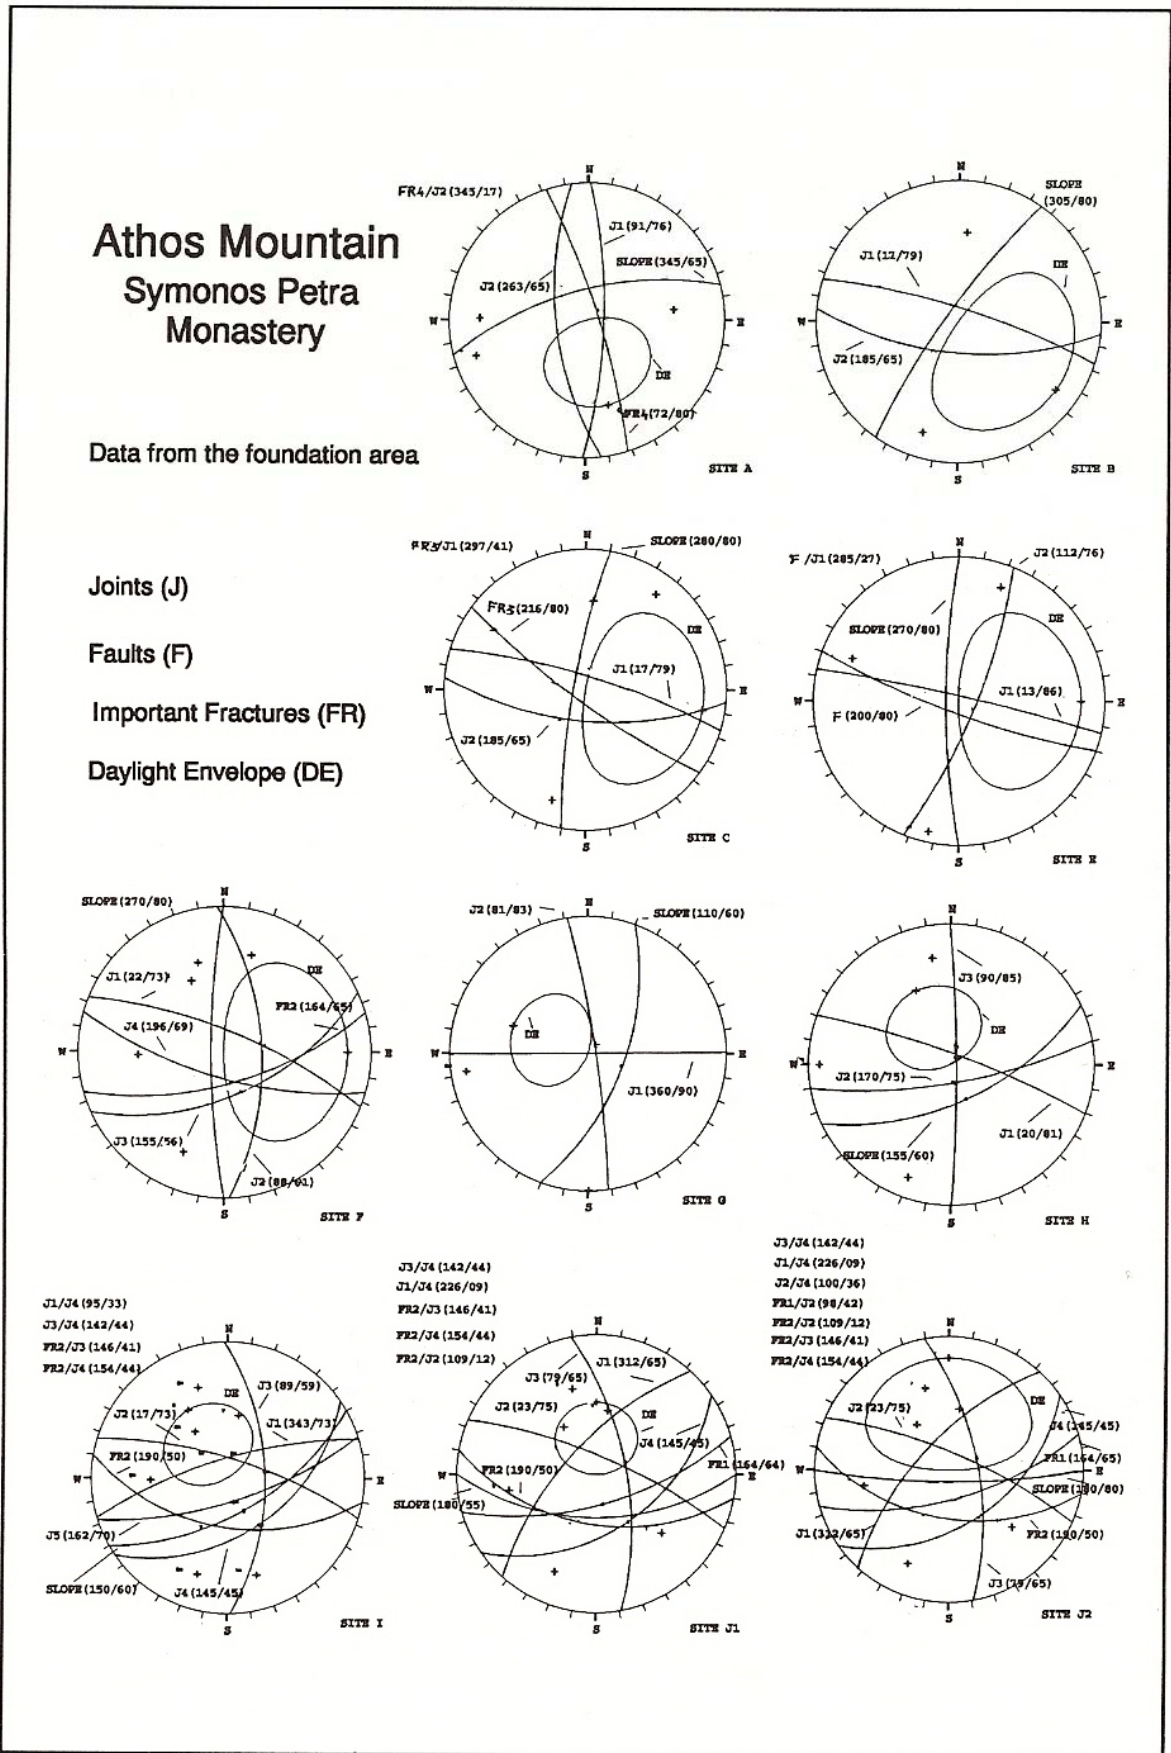
Figure 8. Joint sets from the Monastery rock-hill.

The statistical interpretation of the collected tectonic data provided that the southern part of the studied rock-hill, is probably the more unstable one. At the other sites, the poles of the calculated joint sets don't fall in the daylight envelope. Furthermore, the intersections of the joint sets don't correspond to unstable wedge failure conditions.
