Weathering phenomena on the Hagia Sophia Basilica Konstantinople

In situ investigation Construction Materials and Weathering Phenomena: Preliminary results

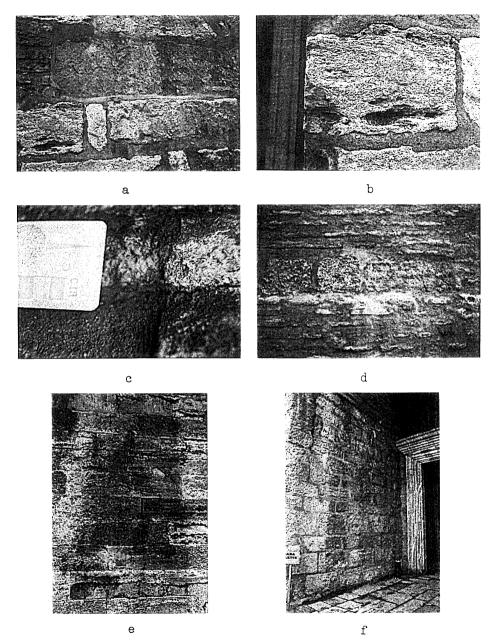
as main building stone, biogenic porous limestone is consisted of large and fine fossils in a coherent calcitic matrix. It deteriorates through granular disintegration in the form of alveolar disease like pitting and cavities, as well as following the "striped pattern" in parallel to the layers of the rock, according to microclimatic differentiations.

These forms of stone decay are due to ground water rising by capillary effect, and to soluble salts actions (crystallisation decay). High permanent humidity in the masonry is witnessed macroscopically, as well, whereas biological attack, favoured by the water, is discernible (fig 1: a-f).

Black crust formation seems to characterise as a general weathering form, masonry surfaces constructed of all the building and joint materials (a,d,f), where microclimatic conditions are in favour of traffic pollutants (SO₂) and suspended particles deposition.

Figure 1: Masonry building materials. Fossiliferous biogenic limestone's (a,b,c,e,f) weathered according to the alveolar (a,b) and stripped (f) pattern, by granular disintegration (c). Ophiocalcites are sporadically discernible (d to the right) suffering by granular disintegration and alteration to talc. Cementitious mortars (a,b,d,f) of brick dust are weathered out. Masonry build in a "concrete technology" way, where bricks are acting as reinforcements (d).

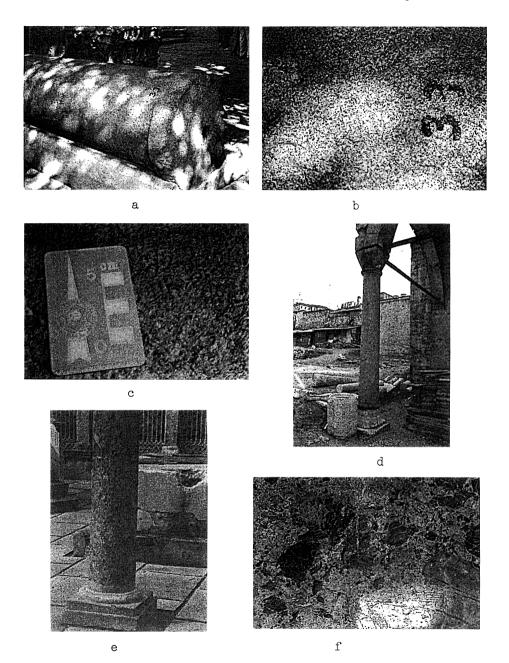
Concerning columns in and around the church, they consist of red and grey biotite granite (figure 2: a,b,c,d), typical of the serbomacedonian mass (Kockel et al, 1977). Although that, granite is characterised from the antiquity as the symbol of strength, given the multiphase character of the material, composed of minerals with different weathering resistance, the weathering process is accelerated. In figure 2b the plagioclase alteration is obvious in the white spots, whereas fissures are observed all over the weathered surface. Columns substituted for ophiolitic breccia (serpentinite) (figure 2: e,f), most probably in a later period, present localised alteration to talc.

Figure 2: Old granite columns (a,b,c,d) and others substituted later by ophiolitic breccia (e,f). Plagioclase alteration and fissures are apparent in the granite weathering (b), whereas Ophiolitic breccia suffers from localised alteration to talc (f).

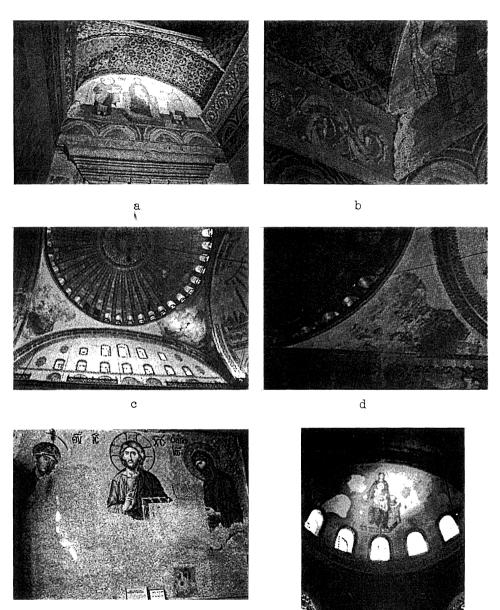
Around the Dome the half Domes, the vaults and the soffits, serious problems of water penetration are witnessed (figure 4a-f), either decolourating iconocraphies (figure 4 a,c,d), or damaging the mortar substrate (figure 4b) and weathering even up to deterioration, the famous mosaics (figure 4 e,f), mostly missing today.

Main problem, arising from the degradation of all the internal materials and objects of art is that of either the rainwater through the Dome, or of permanent wall humidity due to both, rain and capillary rising solutions.

Figure 4: Serious problems of water penetration around the Dome, decolourating iconographies (a,c,d) damaging the mortar substrate (b) and weathering to deterioration famous mosaics (e,f).

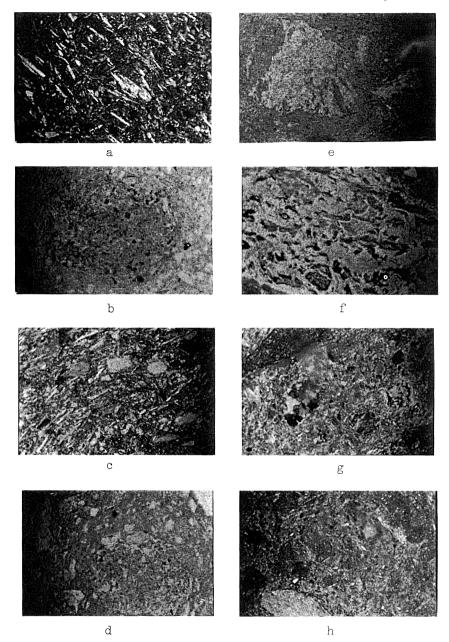
As shown by optical microscopy, (figure.6) a buff sample (4-A) presenting an homogeneous, finely crystallised matrix, with oriented muscovite prevailing (a,b) can be distinguished in comparison with other buff brick samples, like 5 and 3 (c,d//), where larger inclusions of quartz, mica, but also calcite are met. Red

bricks samples 2-B, 1-B and 4-B (e,f,g,h//) present large inclusions of calcite (e,f) in an intensively Fe bearing compounds oxidised matrix with large pores (g,h). In that specific quality among buff bricks, no free calcite in the crystalline phase is identified (table 1) by X-ray diffractometry. I-R diagrams (figure 7, table 3) show on the contrary a main peak of characteristically large surface of AI-Si compounds (table 3). This buff ceramic at scanning electron microscopy examination (figure 5) presents a rather non vitrified matrix, at the level of initial vitrification with high porosity (a,b,c) as compared to other buff (e,f) or red (d) samples, presenting higher vitrification and lower porosity, implying a low firing temperature technology no more than 750oC.

Figure 6 : Optical microscopy x 100 (a-h) Buff bricks, sample A-4 (a,b//) presents an homogeneous finely crystallised matrix with oriented prevailing muscovite, in comparison with other buff brick samples like 5 and 3 (c,d //) where larger inclusions of quartz, mica, but also calcite are met. Red bricks samples 2-B, 1-B and 4-B (e,f, g, h //) present large inclusions of calcite (e, f) in an intensive Fe oxidised matrix with large pores (g, h).
