Landslide along the “Asprovalta-Strymonas” part of Egnatia Highway in Northern Greece.

Keywords: Landslides, slope stability

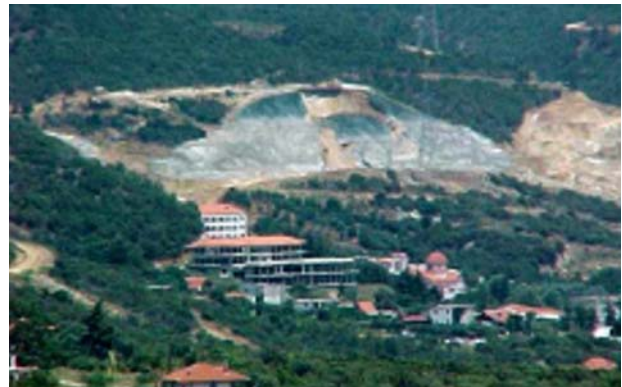
Fig. 1. The landslide in study

The formation of the upper three benches (4th, 3rd and 2nd) had just completed when an extensive landslide took place. The landslide was placed between ch.10+533 and ch.10+620. The sliding of wedge between ch.10+600 and ch.10+620, located in the marble of the 2nd bench, caused the beginning of landslide. The sliding was performed toward to the section of the schistosity 195/39 and joints 278/76. The sliding of the wedge activated new sliding in the neighbor part between ch.10+533 and ch.10+600. The new sliding took place along the direction of gneiss schistosity 213/35 (Chatziangelou & Christaras, 2003). The excavation was interrupted for a long time and a new design of cover and cut was chosen to restore the failure.

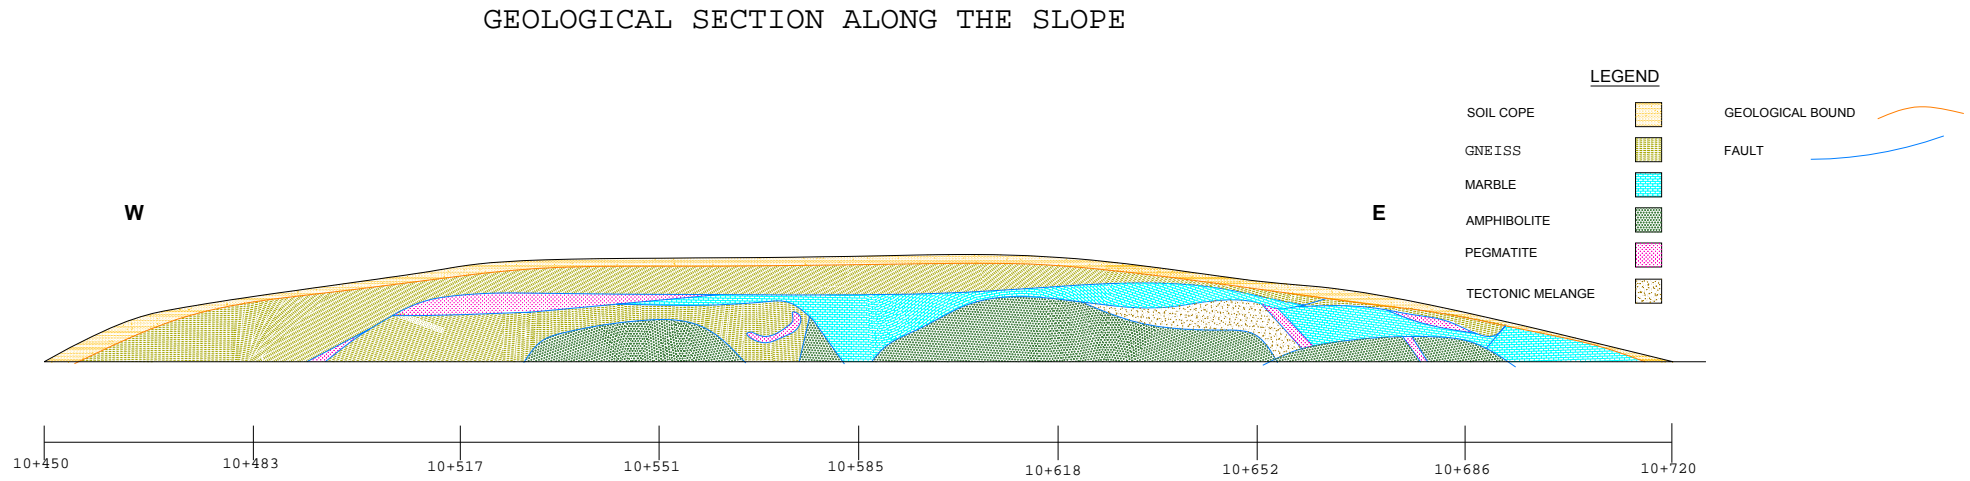
The gneiss and marble are co-folded and cut by three faults with NW, NE and SE directions (Fig.2).

Fig. 2: Geological section along the slope

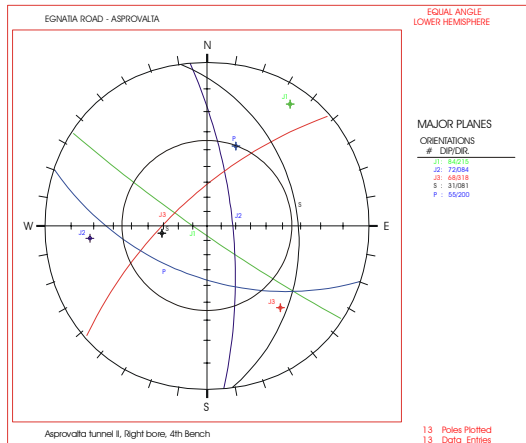
Fig.3: Schmidt diagram along the 4th bench.

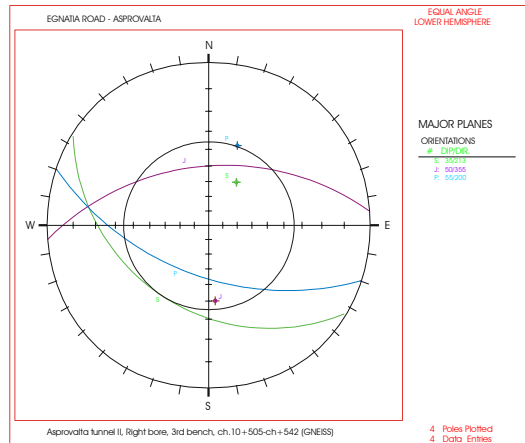
Gneiss formation, being placed between ch.10+505 and ch.10+556 of the 3rd bench, may slide along the direction of schistosity 213/35. The same formation, being placed between ch.10+510 and ch.10+520 of the 2nd bench, may slide along the direction of schistosity 246/42. There is a part of completely weathered gneiss, being placed between ch.10+670 and ch.10+680 of the 2nd bench, which may slide along the direction of the section being formed by schistosity 229/48 and joints 169/53 or 125/85. Marble formation, being placed between ch.10+600 and ch.10+640 of the 2nd bench, may slide along the direction of the section being formed by schistosity 195/39 and joints 278/76 (Fig.3-20).

Fig.4: Schmidt diagram in gneiss along the 3rd bench, between ch.10+505 and ch.10+542.

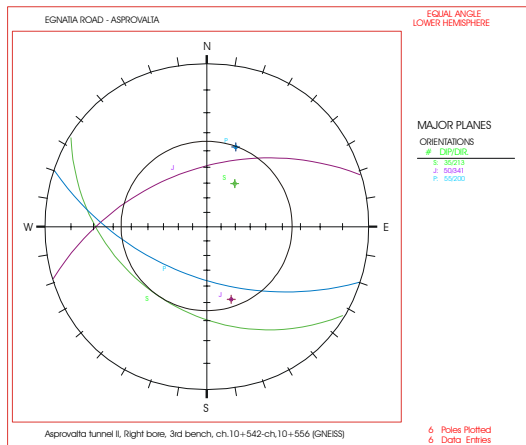
Fig.5: Schmidt diagram in gneiss along the 3rd bench, between ch.10+542 and ch.10+556

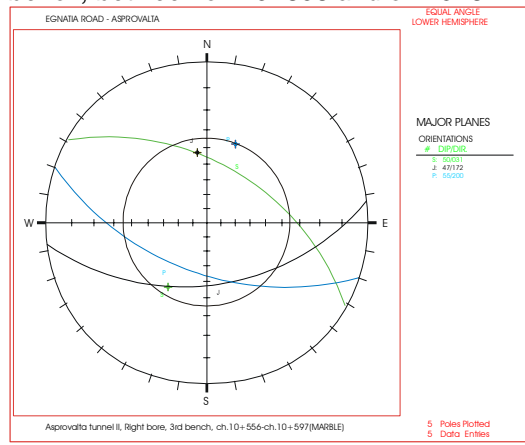
Fig.6: Schmidt diagram in marble along the 3rd bench, between ch.10+556 and ch.10+597

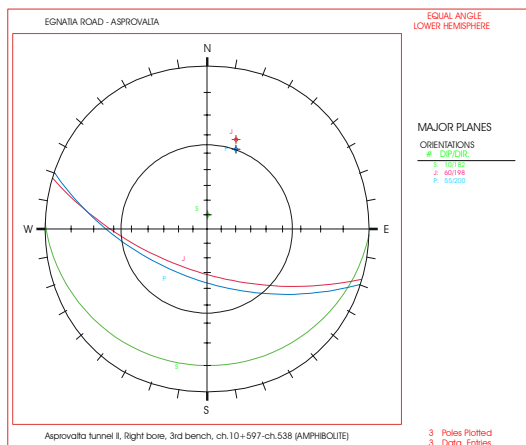
Fig.7: Schmidt diagram in amphibolites along the 3rd bench, between ch.10+597 and ch.10+638 of

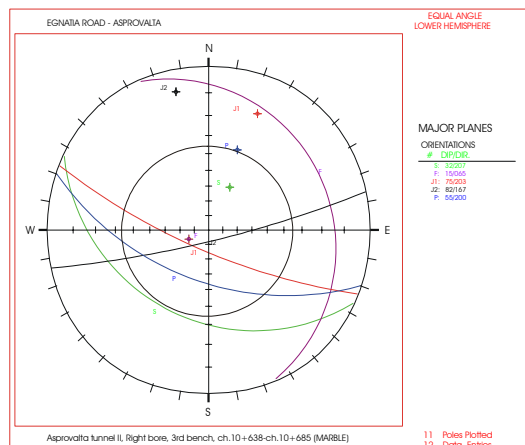
Fig.8: Schmidt diagram in marble, along the 3rd bench, between ch.10+638 and ch.10+685

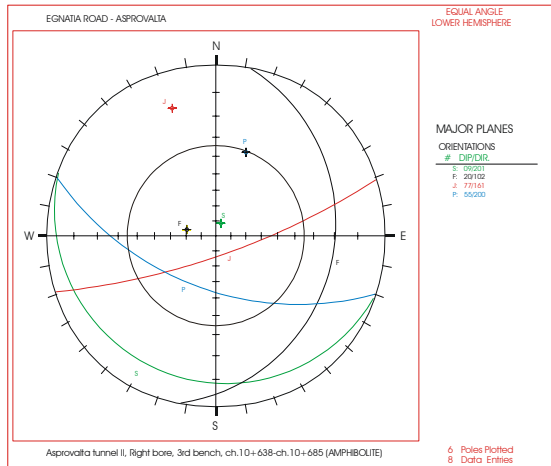
Fig.9: Schmidt diagram in amphibolites, along the 3rd bench, between ch. 10+638 and ch. 10+685

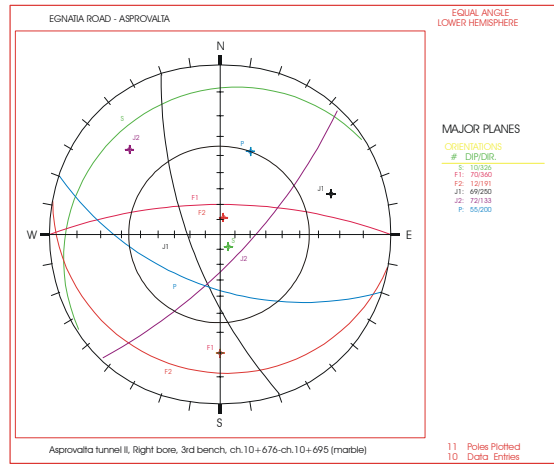
Fig.10: Schmidt diagram in marble, along the 3rd bench, between ch. 10+676 and ch. 10+695

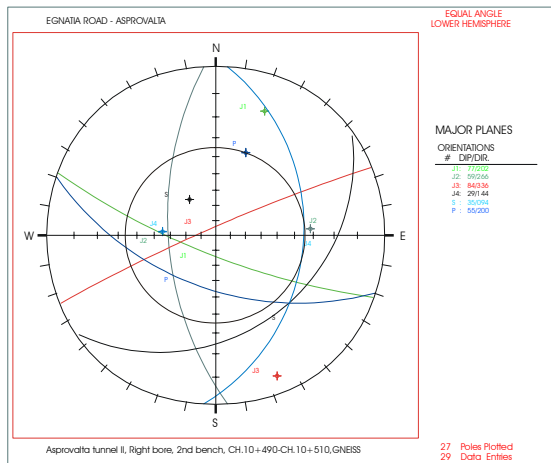
Fig.11: Schmidt diagram in gneiss, along the 2nd bench, between ch. 10+440 and ch. 10+510

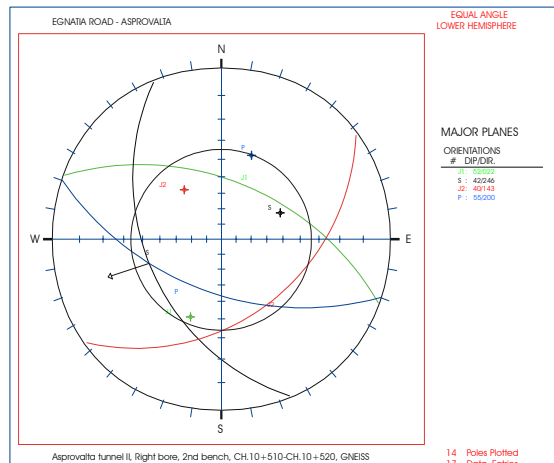
Fig.12: Schmidt diagram in gneiss along the 2nd bench, between ch. 10+510 and ch. 10+520

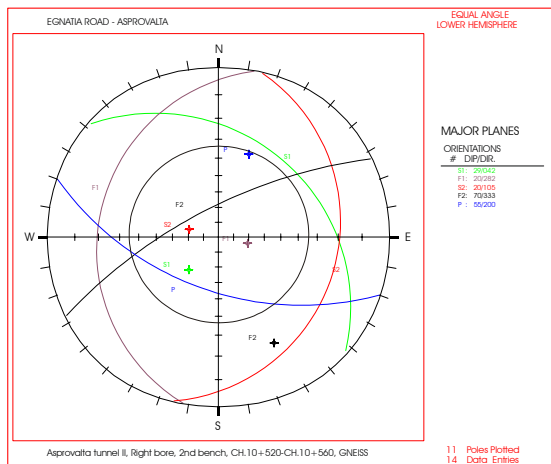
Fig.13: Schmidt diagram in gneiss, along the 2nd bench, between ch. 10+520 and ch. 10+560

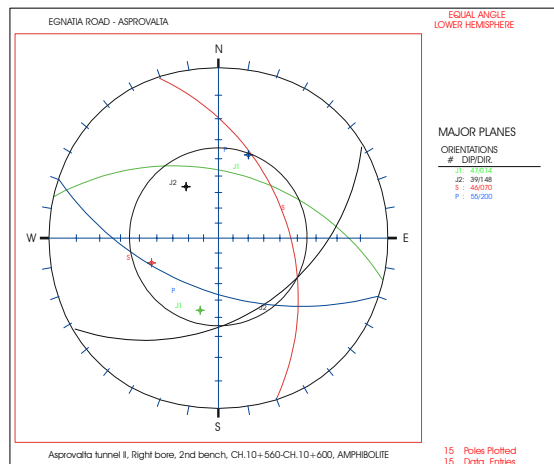
Fig.14: Schmidt diagram in amphibolites, along the 2nd bench, between ch. 10+560 and ch. 10+600

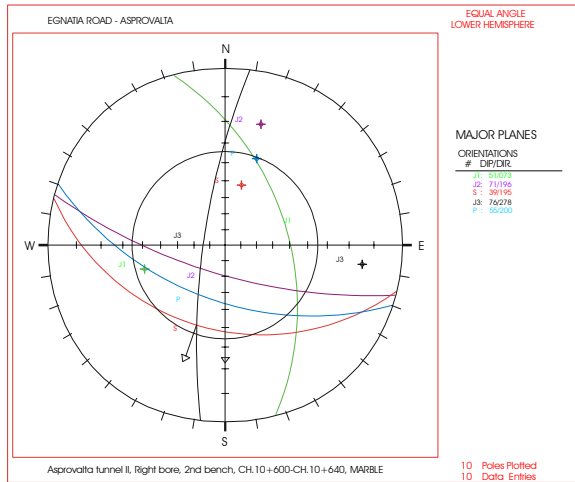
Fig.15: Schmidt diagram in marble, along the 2nd bench, between ch.10+600 and ch.10+640

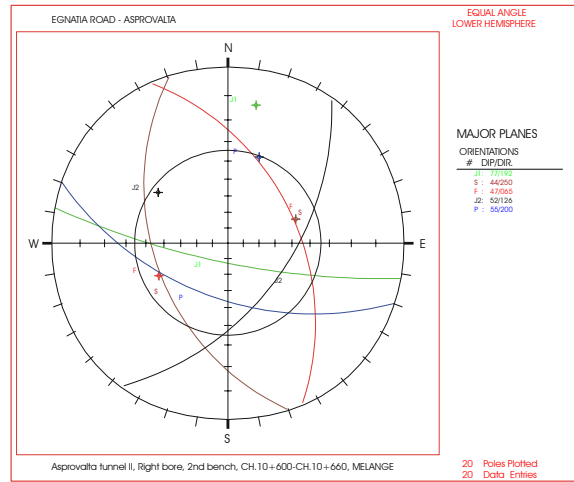
Fig.16: Schmidt diagram in the mélangé, along the 2nd bench, between ch.10+600 and ch.10+660

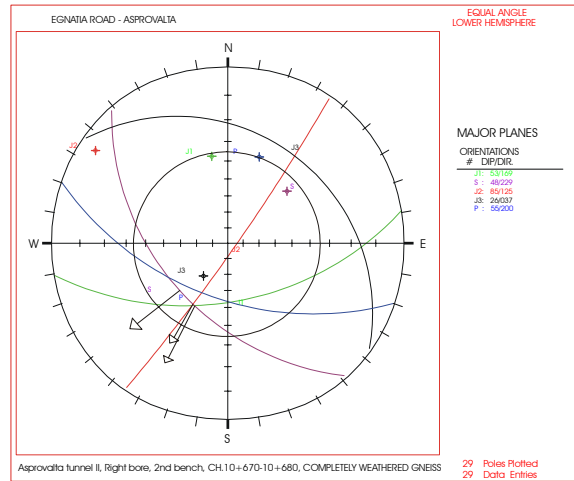
Fig.18: Schmidt diagram in complete weathered gneiss, along the 2nd bench, between ch.10+670 and ch.10+680.

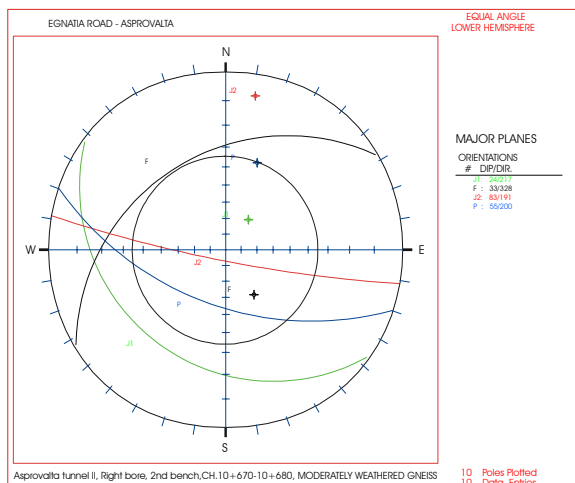
Fig.19: Schmidt diagram in moderately weathered gneiss, along the 2nd bench, between ch.10+670 and ch.10+680

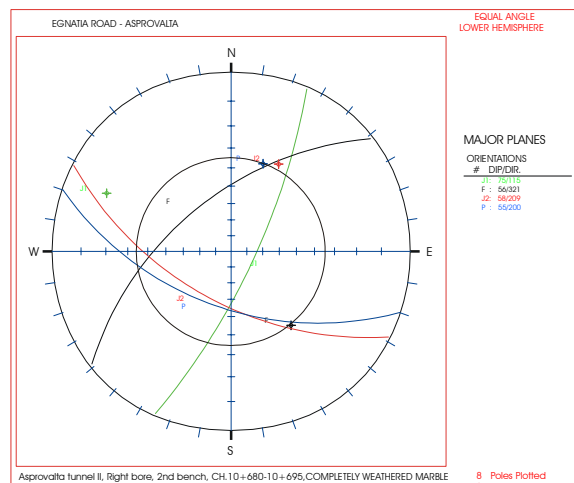
Fig.20: Schmidt diagram in completed weathered gneiss, along the 2nd bench, between ch.10+680 and ch.10+695
