Influence of rainfall on slope stability at Egnatia highway, Asprovalta-Strymonas part (chainage 9+700)

By: Chatziangelou M.¹ & Christaras B.²

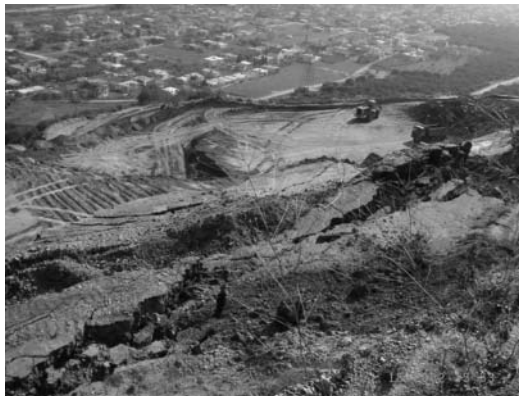
The slope, 60m high (Fig.2), consists of medium to high weathered, cracked biotitic gneiss. The water of a short rainfall decreased the safety of slope and created landslide. The landslide is bounded at the half-formed part of the slope. So, methods for increasing the safety factor are studied.

Fig. 2: Landslide view
