**Innovative Technologies and
Materials for the Protection of
Cultural Heritage.
Industry, Research, Education:
European Acts and Perspectives**

PRELIMINARY DATA ON THE STABILITY CONDITIONS OF POLIPHIMOS CAVE, NEAR MARONIA TOWN IN EASTERN GREECE

Christaras B.¹, Chatzigogos Th.² Dimitriou An.¹ Filippidis S.¹ & Chatzigogos N.¹

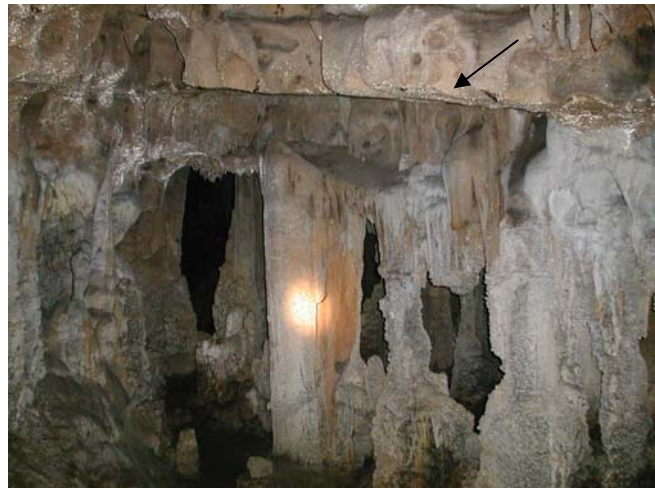
Figure 3. Failure on the roof on the bedding plane

However, the only failures recorded in situ were situated at the ceiling of the cave (Figure 3) and no failures were observed at the sides. This is probably because the mechanical behavior of the joints appears to be better due to the existence of the infilling material at the majority of them as mentioned above (Figure 6). The values of the mechanical properties used in this analysis appear to be representative only for the bedding planes where no filling material is present.

- The instability conditions observed in situ are mainly unstable blocks falling from the roof.
- The cave system tends to become exposed at the surface by the gradual collapse of the roof.
- The filling material of the discontinuities seems to improve their mechanical properties.
- The proposed reinforcing and supporting measures are recommended to be locally applied only on sites where block instability occurs.
- Specific care should be taken on sites where other interventions need to be performed for the shaping of the visiting route.
- At this point of the data elaboration the use of rock bolting as reinforcing measure appears to be the most appropriate.
- The design of the proposed supporting measures aim to the least disturbance of the natural cave.
