Bulletin of the Geological Soci-
ety of Greece, 2010
Proceedings of the 12th Interna-
tional Congress, Patras, May,
2010

PRELIMINARY RESULTS REGARDING THE ROCK FALLS OF DECEMBER 17, 2009 AT TEMPI, GREECE

Christaras B.¹, Papathanassiou G.¹, Vouvalidis K.², Pavlides S.¹

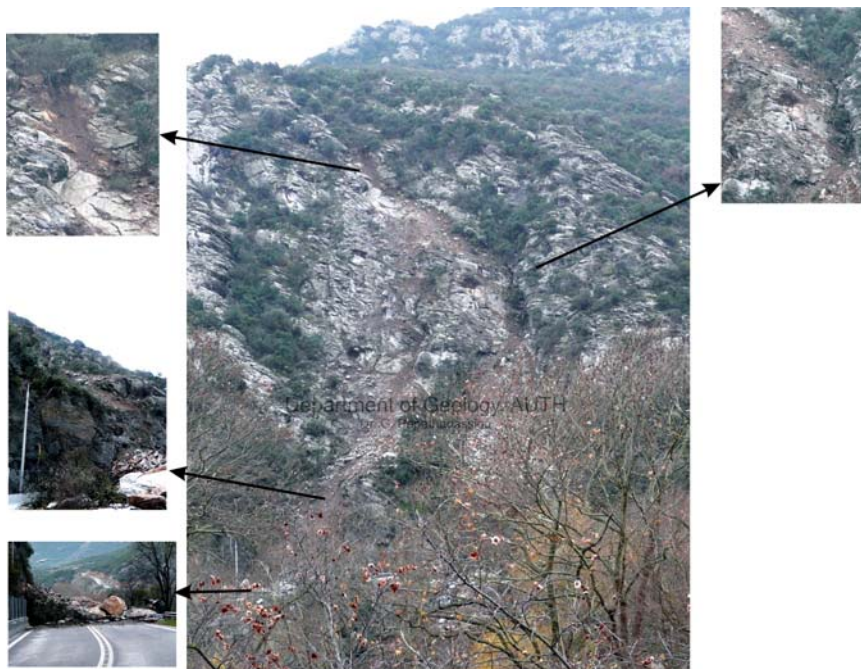
Figure 2. Source area and path of the of rock falls

On December 17, 2009 large size slope instability took place at the area of Tempi, central Greece resulting to one casualty and the permanent close of the national road Athens-Thessaloniki. In particular a large block was detached from a high up to 70 meters and moved downward (figure 2). During its fall the initial boulder triggered the detachment of smaller rocks, creating a combination of rock falls and rock slides. As it is shown in figure 3, the fall track of this failure is separated into two paths.

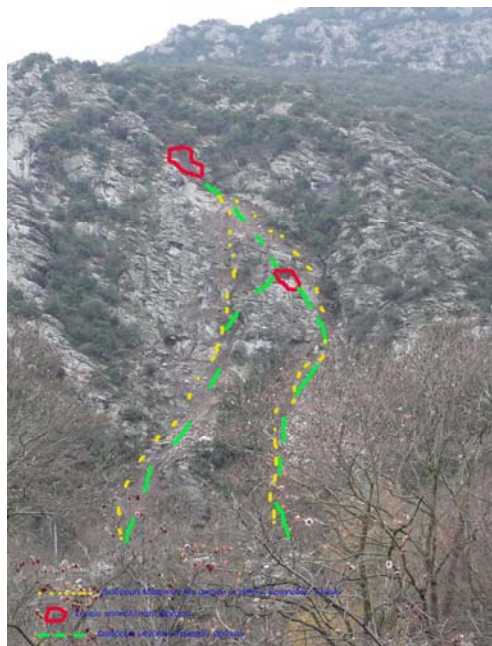
Figure 3. Fall track of the boulders (red circles indicate the source area and green lines show the path)

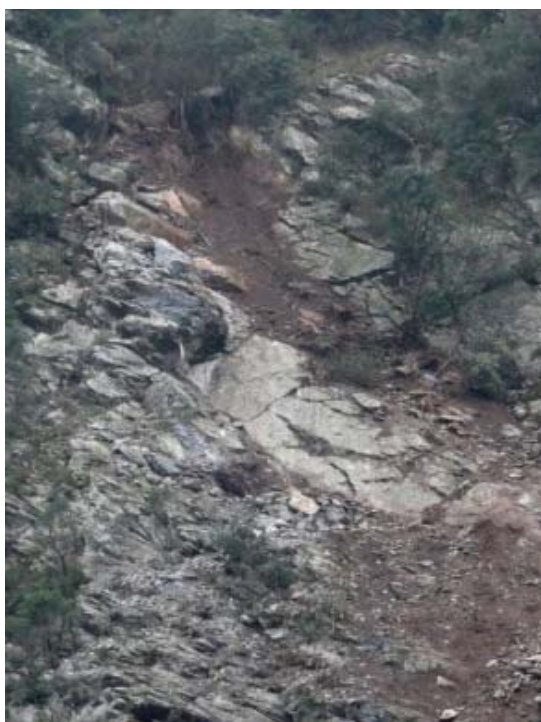
Figure 6. The initiation of the slope failure originated as sliding along the joint 350/47

Three main tectonic systems are found in the area, given in Table 2. In the area where the failure was generated most unstable conditions of rock slopes are related to planar weaknesses. Wedge failures most likely where line of intersection of two fracture planes dips $< \phi$ and daylights in slope. The studied failure started by the sliding of a big block along the joint 350/47 (Fig. 6) which activated and drifted smaller geomaterials, down slope, toward the road (Fig. 7). The bedding of the crystalline limestone is 110/10 (Fig. 8). The related stability analysis of the slope is given in Fig. 9.

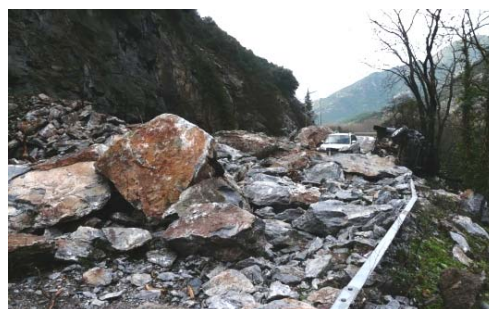
Figure 7. Boulders on the road

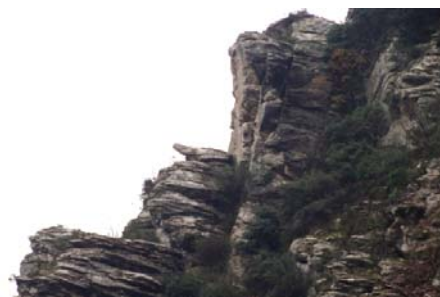
Figure 8. Bedding 110/10 and fault 20/80

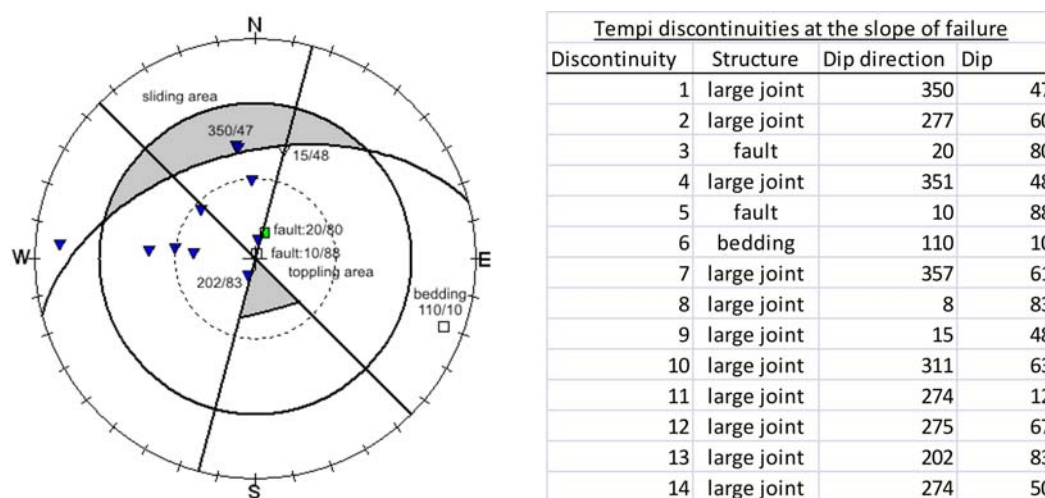
According to Fig. 9, joint 350/47, corresponded to the field observed sliding surface, is limited included in the sliding area of stability analysis diagram, confirming the limited stability of the

slope. This block was retaining in situ, for long time, as joint surfaces are not, usually, totally open, but some small retaining “bridges”, remain inside the rock-mass and keep the stone parts together. Another joint, with data: 15/48, also gives limited safety conditions, even for dry condition, found on the boundary line of the sliding area. Furthermore, another joint, with data: 202/83, is found, on the boundary line of the toppling area of the diagram of Fig. 9. The above data give the impression of a slope with limited general stability, which could decrease in heavy rain conditions, as happened in the studied case.

Figure 9. Stereographic projection of the planes mapped on the rock slope in order to estimate the sliding potential
