Δελτίο της Ελληνικής Γεωλογικής  
Εταιρείας, 2010  
Πρακτικά 12<sup>ου</sup> Διεθνούς Συνεδρί-  
ου, Πάτρα, Μάιος 2010

Bulletin of the Geological Soci-  
ety of Greece, 2010  
Proceedings of the 12<sup>th</sup> Interna-  
tional Congress, Patras, May,  
2010

## EVALUATING THE TRIGGERING FACTORS OF THE ROCK FALLS OF 16<sup>TH</sup> AND 21<sup>ST</sup> DECEMBER 2009 IN NEA FOKEA, CHALKIDIKI, NORTHERN GREECE

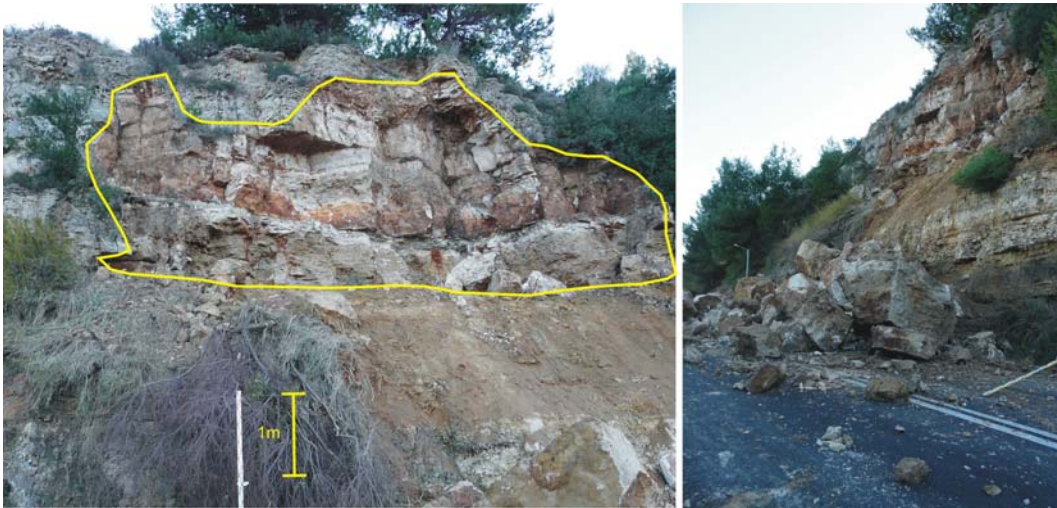
However, few days later, on Monday morning of December 21<sup>st</sup>, a larger scale slope failure happened. As shown in figure 4, boulders with volume ranging from 2 to 15m<sup>3</sup> fell on the road from a height of 10 meters, causing the permanent closure of the country road. A few hours after the second slope failure, a field survey took place in order to examine the rock falls and evaluate the triggering factors.

**Fig 4. Source area of the December 21, 2009 rock falls.**

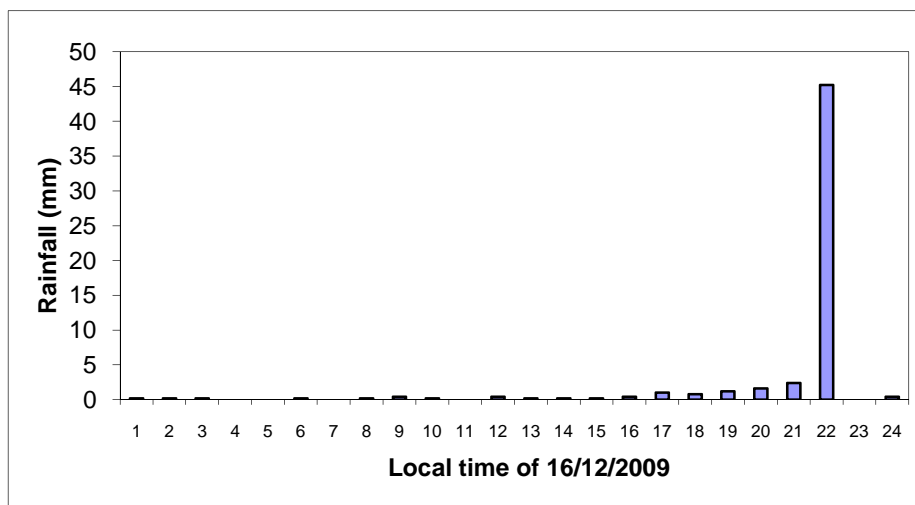
**Fig. 6. The hourly precipitation in Kassandra at 16/12/2009.**

Initially, the monitored precipitation at the Kassandra weather station was examined. The weather station of Kassandra (40°03'N, 23° 25'E, altitude = 37 m) was established by the Aristotle University of Thessaloniki (AUTH) only very recently (since 2007), thus the precipitation records of the period under investigation in Kassandra were compared with the normal values of the same parameter for the period 1961-1990 of AUTH (40°37'N, 22°57'E, altitude = 32 m). In particular, the monthly total rainfall in Kassandra in December 2009 was 68 mm (distributed in 15 days) (Fig. 5), 28% more than the normal amount (53 mm) AUTH received for this month during 1961-1990. The relatively wet December followed the severely dry months of October (6 mm vs. the normal value of 40 mm) and November (3 mm vs. the normal value of 56 mm) of 2009. However, from the above mentioned total amount Kassandra received in December, more than 81% of rainfall (or 56 mm) dropped in one single day (16/12/2009). Although this specific rain episode lasted all day (Fig. 6), more than 80% (45mm) of rain was measured from 21:00 to 22:00 local time.

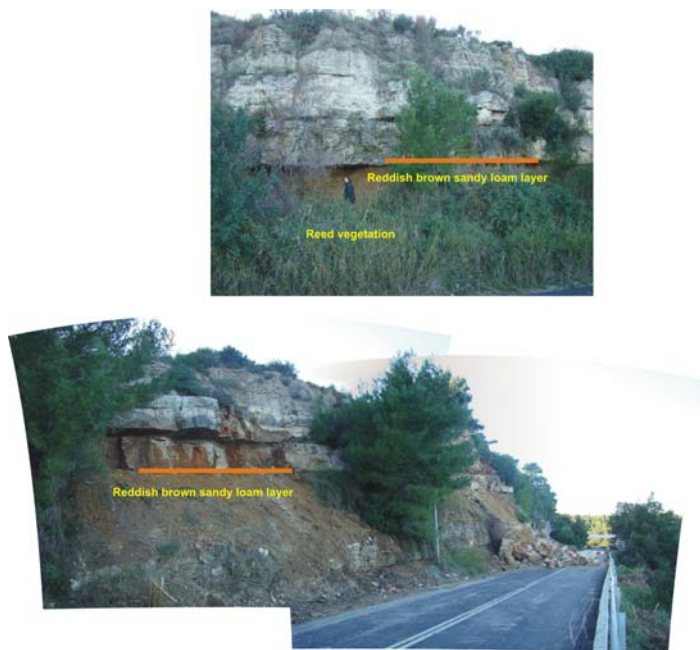
**Fig 7. The layer of reddish-brown sandy loam is slowly washed out by the percolating water from the overlying limestone (note the beginning of undercutting). The water favors thick reed vegetation. It is a matter of time this slow process to undercut the limestone causing a rockfall in this place in the future.**

It is remarkable that within the limestone numerous vertical cracks allow the percolating water to pass downwards, but the intercalation of reddish-brown sandy layer (bed 3) between the limestone beds causes the drying up of the water from the superimposed limestone along this contact. As a result, thick reed vegetation appears along and below the contact. It is also remarkable that this bed of reddish sandy loam prevents water from percolating in the lower strata, resulting to the dryness of contact between the base of the limestone (Trilophos Fm.) and the top of the red beds (Triglia Fm.).

In our cases, the above conclusion precisely describes one of the triggering factors (stratigraphy) and the unstable conditions that were created these specific two days (16<sup>th</sup> and 21<sup>st</sup> of December 2009), thus concluding that in both cases the rock falls were generated by the undercut of the reddish brown sandy loam bed.
