EVALUATING THE TRIGGERING FACTORS OF THE ROCK FALLS OF 16TH AND 21ST DECEMBER 2009 IN NEA FOKEA, CHALKIDIKI, NORTHERN GREECE

Abstract

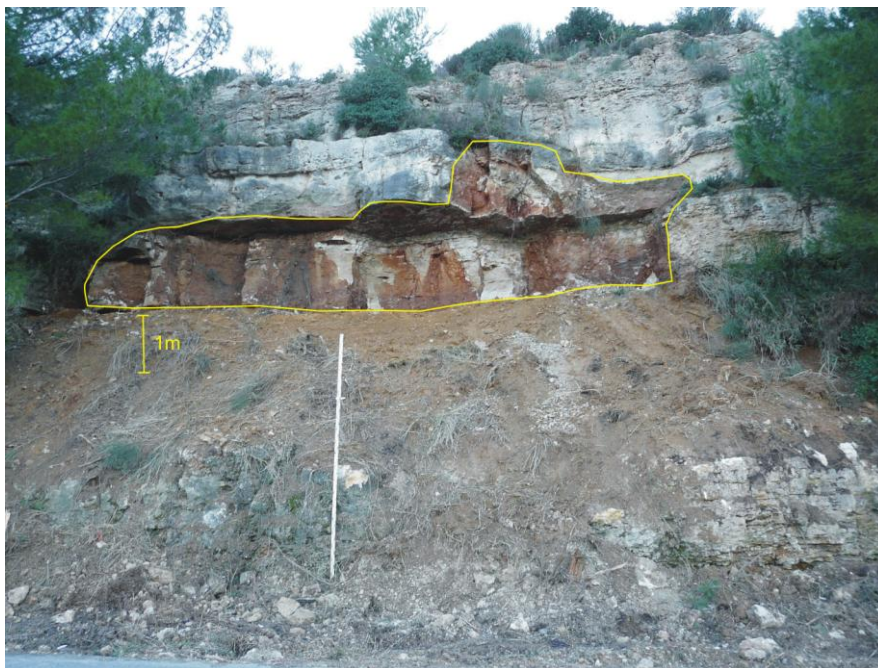
More specifically, on Wednesday, December 16 at 21:30, two large size boulders of 6-8 m³ detached from a height of 8 m and fell onto the road. This rock fall event forced the local authorities to temporally close the road for few hours in order to remove the fallen blocks and construct a new protective metal barrier along the steep slope of the road cut.

Fig 3. Source area of the rock falls occurred on December 16, 2009.

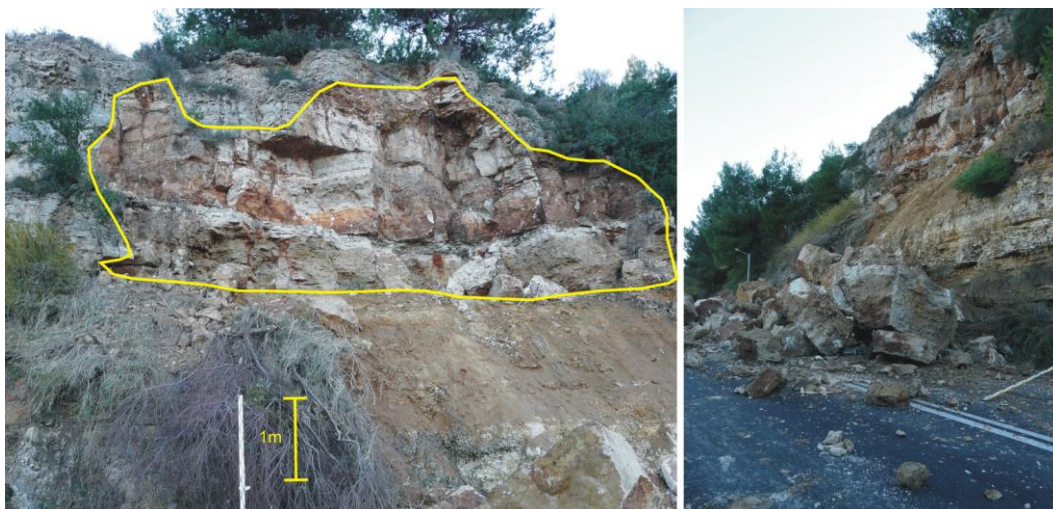
However, few days later, on Monday morning of December 21st, a larger scale slope failure happened. As shown in figure 4, boulders with volume ranging from 2 to 15m³ fell on the road from a height of 10 meters, causing the permanent closure of the country road. A few hours after the second slope failure, a field survey took place in order to examine the rock falls and evaluate the triggering factors.

Fig 4. Source area of the December 21, 2009 rock falls.

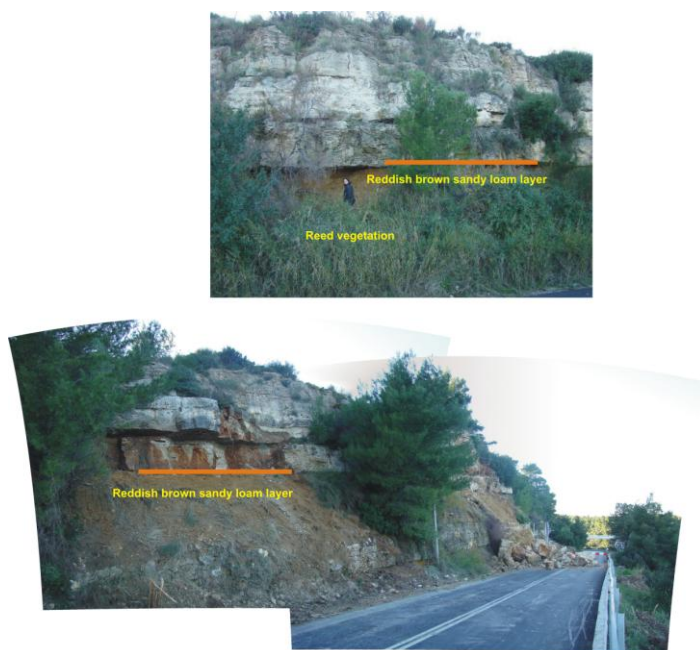
Fig 7. The layer of reddish-brown sandy loam is slowly washed out by the percolating water from the overlying limestone (note the beginning of undercutting). The water favors thick reed vegetation. It is a matter of time this slow process to undercut the limestone causing a rockfall in this place in the future.

It is remarkable that within the limestone numerous vertical cracks allow the percolating water to pass downwards, but the intercalation of reddish-brown sandy layer (bed 3) between the limestone beds causes the drying up of the water from the superimposed limestone along this contact. As a result, thick reed vegetation appears along and below the contact. It is also remarkable that this bed of reddish sandy loam prevents water from percolating in the lower strata, resulting to the dryness of contact between the base of the limestone (Trilophos Fm.) and the top of the red beds (Triglia Fm.).

In our cases, the above conclusion precisely describes one of the triggering factors (stratigraphy) and the unstable conditions that were created these specific two days (16th and 21st of December 2009), thus concluding that in both cases the rock falls were generated by the undercut of the reddish brown sandy loam bed.
