**Deterioration Problems and Preliminary Observations on the  
Conservation of the Building Materials of Excavations of Navarino and  
Diikitirio, Thessaloniki**

**ABSTRACT**

**KEY-WORD:** Brick, mud brick, consolidation, organic coatings

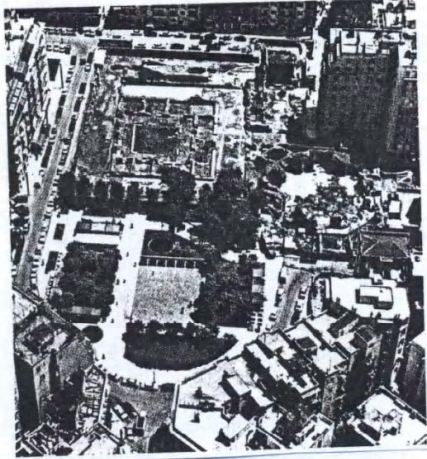
Figure 1. Navarino excavations, a) general view of the complex, b) Palace complex-reconstruction. .

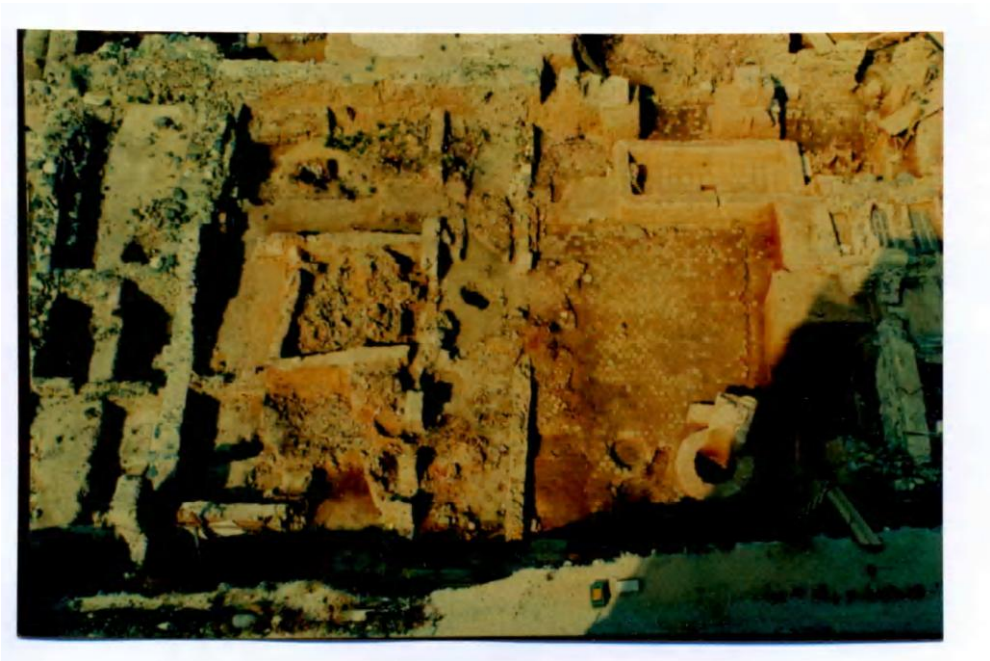
Figure 2. : Diikitirio excavations, general view

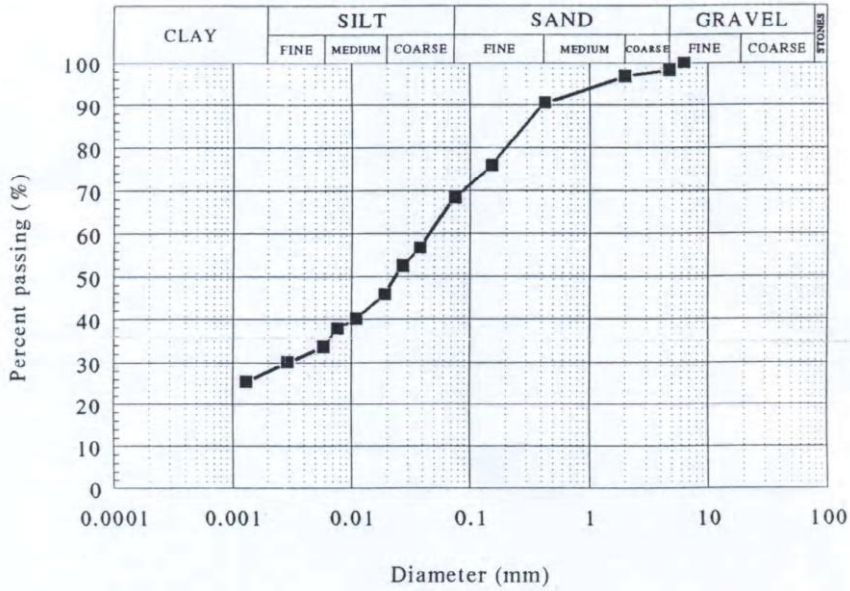
Figure 3. Particle size distribution of samples

The particle size distribution shown in Figure 3 indicates that the material is composed from 75% silt and 25% sand.
