Application of Infrared Thermometry and Ultrasonic Velocity for the Investigation of the Building Materials of Historic Monuments of Dion, Greece

Papanikolaou E.¹, Spathis P.^{2*}, Christaras B.¹, Melfos V.¹, Katsiotis N.³

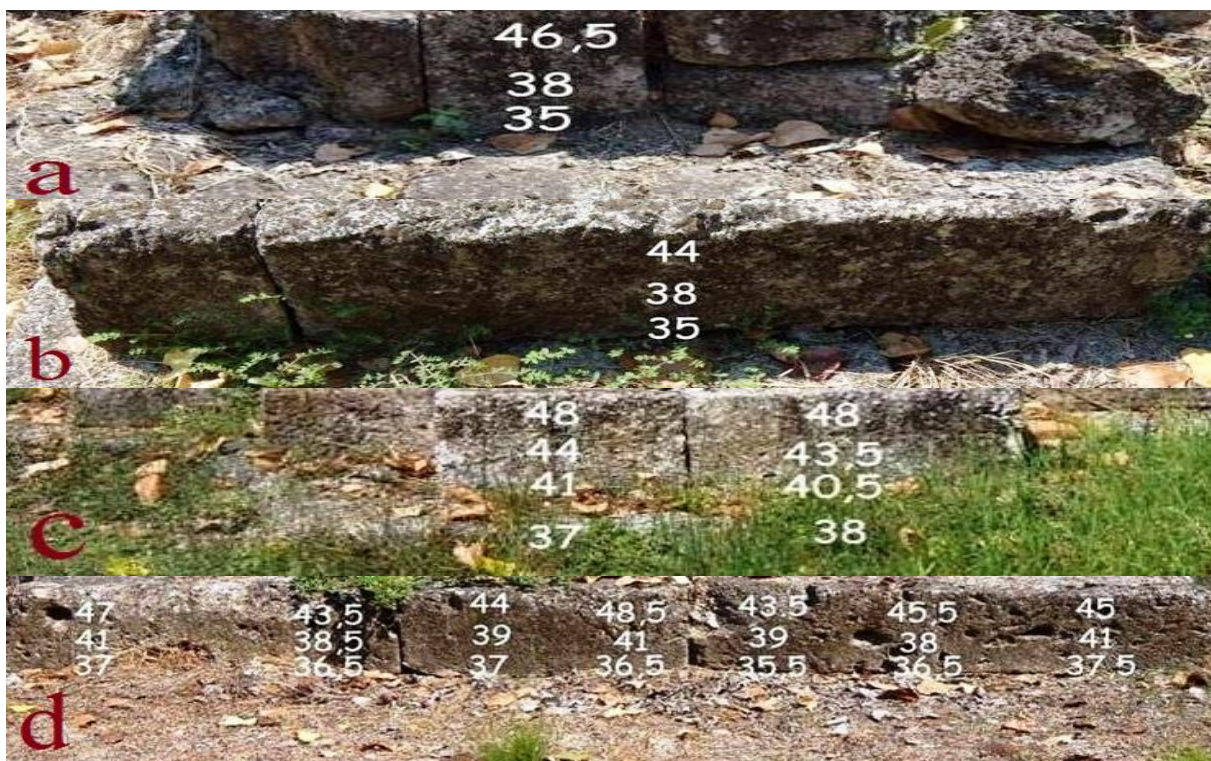
Fig. 4 IR thermometer measurements, sunny conditions, Demeter sanctuary, Altar, a) north side, b) east side, c) south side, d) west side.

The results of the IR thermometer in situ measurements are shown in Figures 3, 4 (sunny conditions) and Figures 5, 6 (wet conditions).

Since a moist porous material presents emittance variations, moisture detection in porous stones by means of IR thermometer measurements is feasible. IR thermometry monitors the water movement in porous materials and detects its impact by recording temperature variations on the stones' surfaces. The presence of moisture (lower temperatures) that arises as a result of the capillary movement of water causes deterioration of the building material. In such cases, the optical properties are altered, the density, specific heat capacity and thermal conductivity are also affected and so any temperature changes are much slower in a moist area, as the energy required to raise the temperature of a moist area would be much greater than an area that is unaffected by water. In all cases of IR thermometer in situ measurements, the recorded temperatures on the side surfaces of the walls increase with the distance from the ground. The temperature differences depend mainly on the environmental conditions (sunny or wet), also on the kind of the material and the orientation of the wall, being greater in sunny and smaller in wet conditions. The IR thermometer measurements correlated with the water and capillary absorption and desorption results (Table 1) and also the permanent intensive presence of surface and underground waters indicate that the main deteriorating factor of the materials is the moisture penetration due to capillary action. In sunny conditions, moisture penetrates into the materials only by capillary absorption (greater temperature differences, Figs 3, 4), while in wet conditions rain water and environmental humidity contribute also to the total moisture absorption (smaller temperature differences, Figs 5, 6).

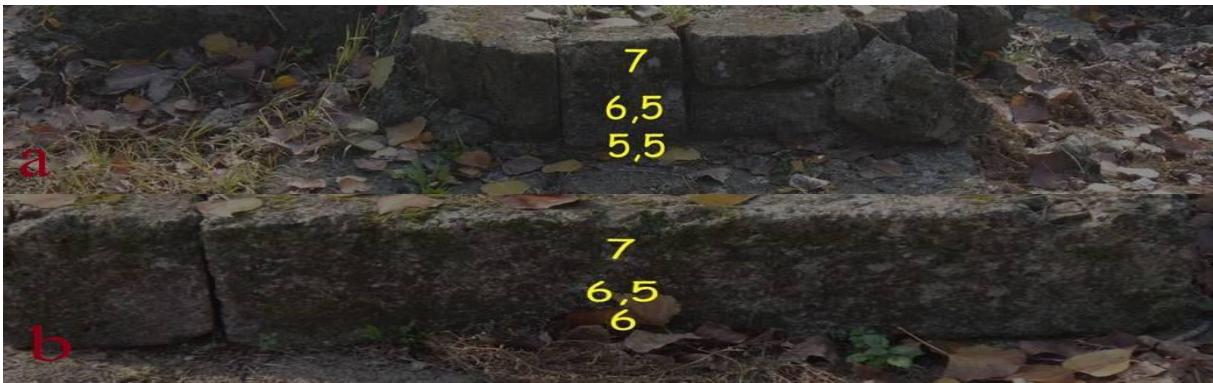
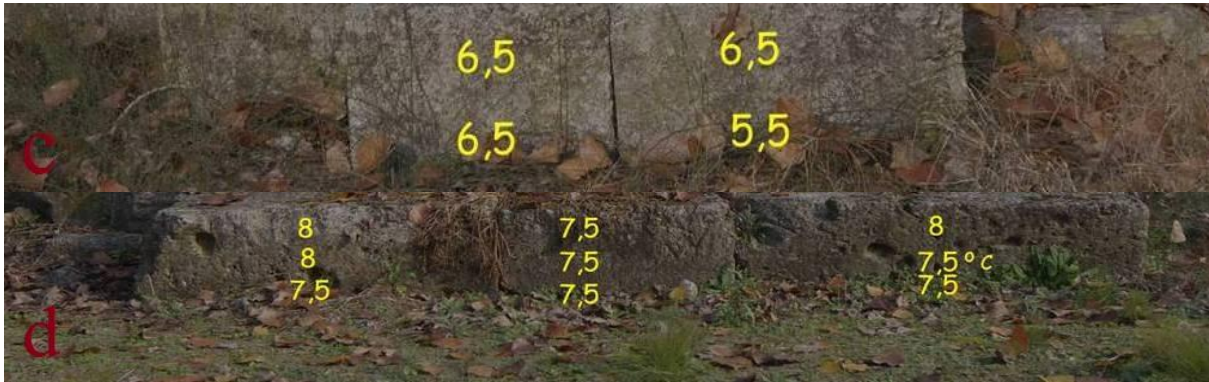
Fig. 6 IR thermometer measurements, wet conditions, Demeter sanctuary, Altar, a) north side, b) east side, c) south side, d) west side.
