# OLD STONE BRIDGES IN EPIRUS, GREECE HARDNESS TEST USING A THIN SECTION LAPPING MACHINE

*School of Geology, Lab. Engin. Geology & Hydrogeology, Aristotle University,  
54006 Thessaloniki, Greece.*

In the present investigation the stability of the old stone bridges and the weathering conditions of the raw materials were studied experimentally by means of hardness test, sonic velocity, dry density and water absorption determination; thin sections of these stones were studied also. Hardness was measured as abrasion loss of weight using a thin section lapping machine. Test results were sufficiently related to the weathering.

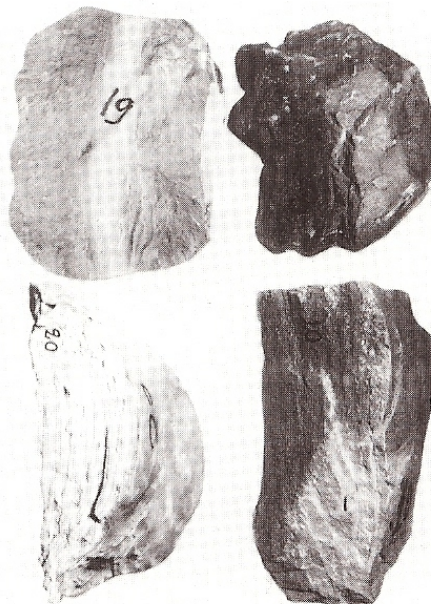
The building stones of the bridges are moderately weathered presenting usually a 20-30 % of weathering. The weathering starting from the surface continues inward, displaying a zonation (Fig. 6.8, 6.10, 6.19).

Fig. 6 : Building stone samples showing a zonal weathering.  
8, 10 : Sandstones; 19 : Limestones; 20 : secondary calcite which cover building stones.

Although these bridges are not any more used in our days for transportation, it is necessary to be preserved by the State, as their construction technique was unique. Loose blocks (Fig. 5 c), zonal weathering of stones, starting from the surface and continuing inward (Fig. 6.8, 6.10, 6.19) and creating "stalactites" of secondary calcite (Fig. 5 e, 6.20) cause damage of these bridges, in relation to the tectonic conditions. The purpose of this investigation was a first approach to estimate the damage of these old bridges so that the more proper conservation measurements to be taken. A thin section polishing machine used for abrasion loss of weight measurements, as hardness and weathering values gave quite good results.

composition (together with quartz) of its groundmass. Both limestone and sandstone building materials are entirely covered of secondary calcite, looking sometimes like stalactites (Fig. 5 e, 6.20). Tectonic and slope stability conditions provoke big cracks on the body of the bridges causing the loosening of the blocks (Fig. 5 c).
