**Engineering Geological Factors of Damage at
Greek Monuments and Sites included in the
World Heritage List of UNESCO**

BASILE CHRISTARAS

**International Association of Engineering Geology and the Environment (IAEG) -Commission 16
“Engineering Geology and Protection of Ancient Monuments and Archaeological Sites”**

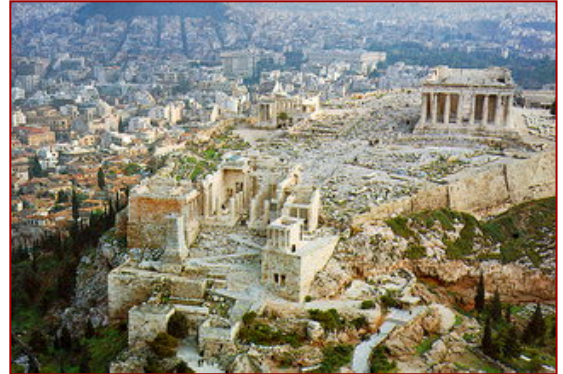
The Acropolis of Athens

The Acropolis (and Parthenon) is built on an isolated and uplifted rock consisted of massive to thickbedded limestone. Big unstable blocks are created on the steep slopes of the hill because of the karstification and the tectonic. The joint net is locally close spaced, with planes of considerable length, fairly dipping towards the slope. Except karstification the rock is subjected to the air prolusion, the temperature variation and the mechanical action of the wind. The former situation causes important rock falls that generate damages to the monuments and the surrounding buildings.

- 1) Limited retaining walls (discreet) with drainage
- 2) Systematic rock bolts
- 3) Intensive rock bolting on hang over boulders
- 4) Filling of the joints with concrete to reduce infiltration.
- 5) Construction of intensive drainage system of the top platform to reduce infiltration.

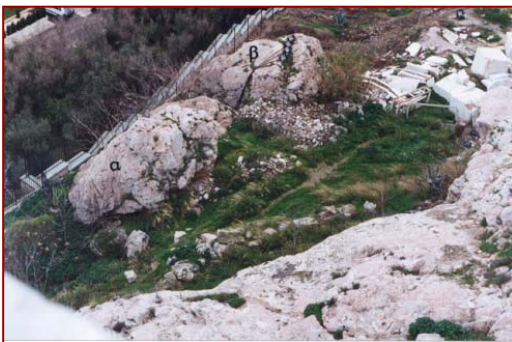
Rockfalls

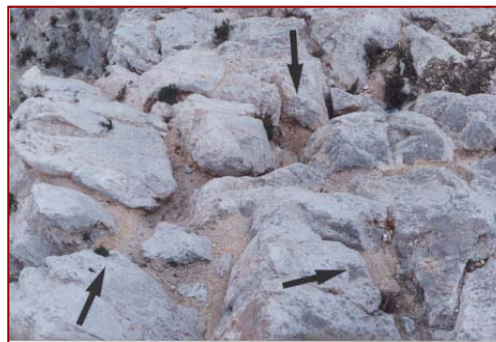
Filled joints

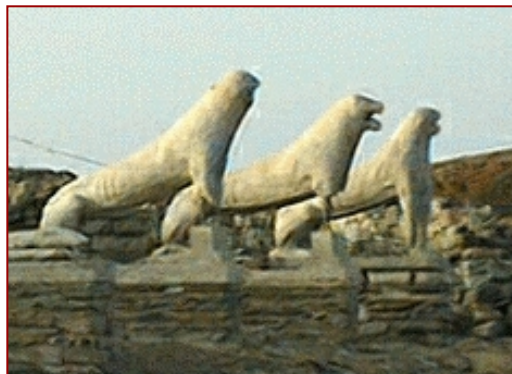
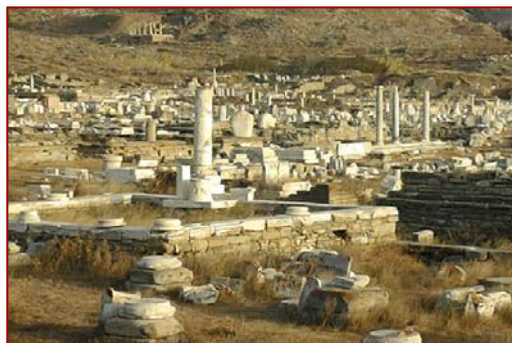
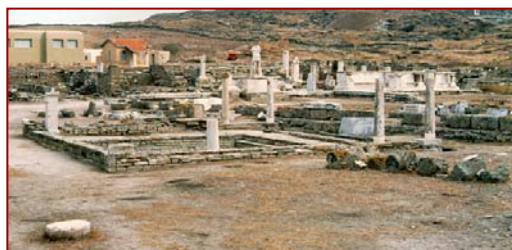
- Weathering of stones (marble and granite) by polluted atmosphere and marine spray.
- Decays by supply of matter such as brown crusts (on marbles sheltered from rain).
- Damages by loss of matter such as dissolution (on marbles exposed to rain).
- Other degradations by loss of matter such as granular disintegration and contour scaling (on parts exposed to rain).
- The presence of marine salts leads to dissolution and crystallization cycles of salts, especially inside the marble and the granite porous network. This mechanism occurs: a) by capillary transfer of water and salts from the ground and b) by fixation of water vapor by sea-salts deposited on the stone by the wind.

- Protection against weathering of building stones
- Consolidation of weathered surfaces using appropriate materials which do not cause damage to the other parts.
- Diagnosis of damage and consolidation result using non destructive techniques

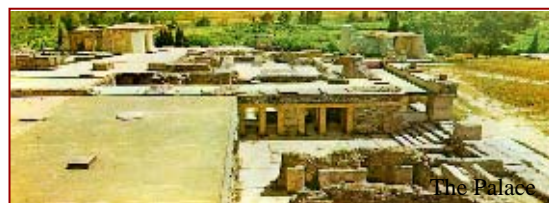
The Palace

• An earthquake and probable eruptions of Thyra volcano destroyed the town before 1890 BC. The new Palace built in 1700 BC and destroyed in 1570 BC, by an earthquake. It was rebuilt in 1450 BC and redestroyed in 1375 BC. A new town which was built, was destroyed definitively in 823 AD.

• Weathering of natural building materials is an important cause of damage.

- Restoration of buildings
- Conservation of the building stones consisting mainly of biogenic limestone, marly limestone and gypsum.
- Conservation of frescos is also needed

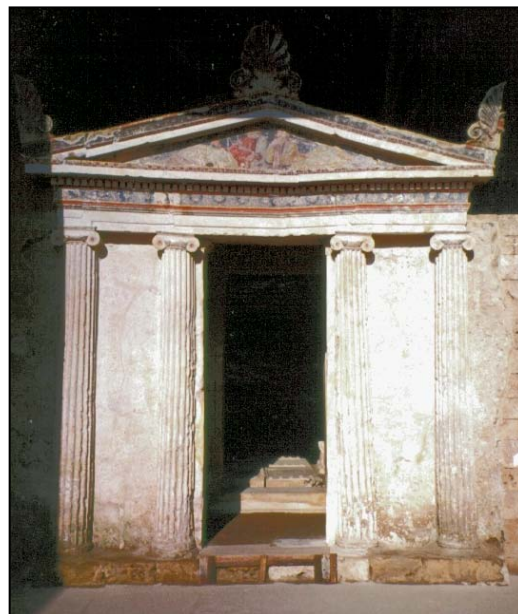
The damages are mainly related to the groundwater, which, usually covers, the floor of the monuments. Furthermore, differential settlements cause damage to the stability of the monuments while the existed humidity causes damage to the frescos. The formations in which the Tombs are buried, are consisted of alluvial deposits with clay, sand, gravel and conglomerates. The soil materials are generally loose and coarse grained, presenting, active porosity and permeability that vary depending on the grain size distribution of the soil. The depth of the groundwater varies from 7.5 to 8 m. The permeability of the soil is $2-3 \cdot 10^{-2}$ and the hydraulic gradient 12-14 %

- The tombs need permanent drainage.
- A pumping borehole system is already established
- A drainage trench could involve to the better drainage
- An impermeation grouting shell was calculated to be constructed in order to permanently protect the tombs from the water. The number of the boreholes that is needed to impermeate the building that includes the Krisis tomb is 46 and for the Krisis tomb is 24. The total length of boreholes for the first case is 750,54m and for the other one is 297,62m

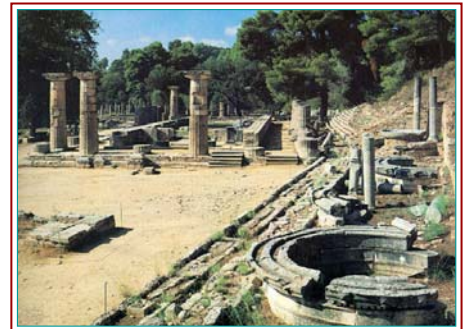
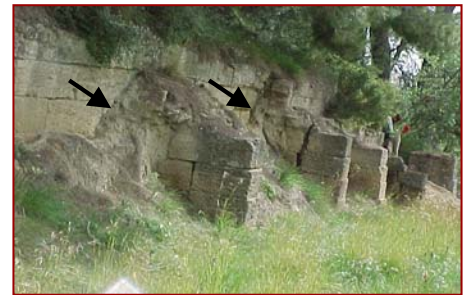
The archaeological site is limited to the north by a steep hill slope, which is crossed by a national road of heavy circulation. The slope (at the level of the archaeological site) consists of fine-grained soil, classified as silty clay to silty clayey sand of low plasticity. According to the grain size analysis of representative specimens, the material is composed of 22-17% clay, 43-80% silt and 35-3% sand. The liquid limit (LL) of the above specimens is 30-32%, the plastic limit (PL) is 22 and the plasticity index (PI) is 8-10%. The material presents low permeability and drainage ability. In dry conditions the material in compact, presenting uniaxial strength of 5-15 MPa. According to the performed UU triaxial tests, the cohesion is 17-23.7 Kpa and the angle of internal friction is 5,2-11⁰. In rain conditions the material is sutured rapidly, providing unstable conditions with earth pressures on the old rocky wall. According to our stability analysis, a safety factor of S.F<1 determines the instability of the lower part of the slope, under the road, toward the archaeological site

- Drainage of the slope,
- Removal of the roots of the trees at the lower part of the slope.
- A shallow vegetation retaining system could also improve the stability of the upper parts of the hill-slope.
- The methods used for reinforcing the ancient retaining wall should be adapted to the identity of the archaeological site.

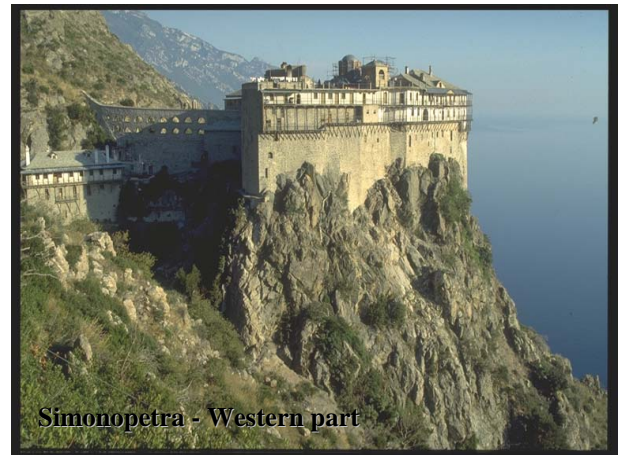
Simonopetra - Western part

The tectonic structures determined in the area cause unstable geotechnical conditions at the foundation rock mass. The presence of an important neotectonic fault of SW dip direction distinguishes two sections in the rock mass decreasing the stability of the Monastery. Furthermore, an important fault of E-W direction cuts through the site close to the building's western wall, creating fractures both to the building and the foundation rock.

A slope stability analysis was performed with the determination of important unstable wedge and planar failures and the calculation of their factors of safety, using both field measurements and laboratory test results. The rock mass quality was estimated at several representative sites and a geomechanical classification was performed. According to the results of the data elaboration, the rock mass quality in the southern and western slopes of the foundation area is low and of limited stability, causing damage to the monument. These instability phenomena are related to the neotectonic conditions of the broader area.

In order to protect the monument, a net bolts is necessary to be applied, in the sites where the approach is possible. Grouting could be used only in cases where the material is very broken and the discontinuities open. All the protection techniques have to respect the environment.

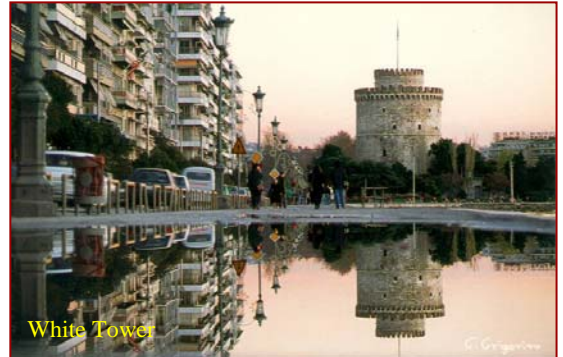
- The city was founded in 315 BC
- Quaternary and anthropogenic deposits (fine to coarse grained deposits)
- Settlement phenomena.
- Ground water presence
- Humidity and weathering of stones, mortars and frescos (icons).
- Stability of the monuments related to static, geotechnical and seismic causes.

- Stabilization of the foundation and masonry of the churches especially after the earthquake of 1978.
- Confrontation of the settlements and other geotechnical causes
- Consolidation of stones and mortars
- Conservation of frescos (icons) and mosaics
- Other restoration activities on the roman, paleochristian and byzantine monuments - eg. Roman Agora (3rd c. AD), Roman Palace (3rd c. AD), Arc of Galerius (3rd c. AD), Rotonda (3rd c. AD), Achaeropeitos church (5th c. AD), St. Demetrios church (5th c. AD), St. Sophia church (7th c. AD), Virgin of Halkes church (11th c. AD), Transfiguration (Metamorphosis) of our Lord church (14th c. AD), White Tower (15th c. AD) etc. The mosques and the baths of the turkish period are also under restoration.
