## QUEDLINBURG - CASTLE MOUNTAIN (BURGBERG)

World Cultural Heritage since 1994

### Engineering geological conditions and problems:

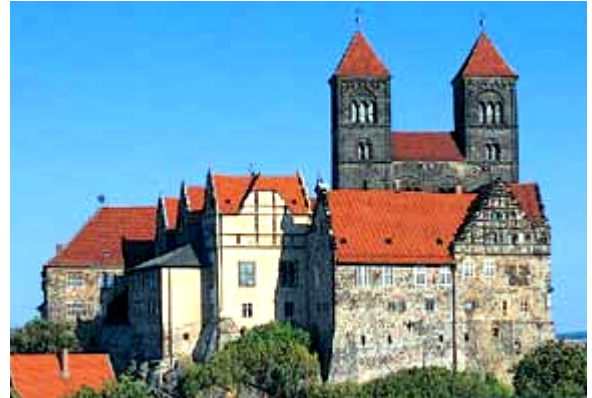
The buildings are founded in exposed position on a hill top on partly friable or deconsolidated Cretaceous sandstone. Near the steep cliffs around the hill margin stability problems are causing serious construction damages. High building loads and inhomogeneous engineering geological conditions require specific geo-engineering stabilisation measures.

*Castle Mountain*

Foundation soil analysis have been repeatedly carried out since 1914. During the past decades the buildings have been monitored with specific measurement techniques (photogrammetry, stretch measurements). Currently geophysical (nearseismic-geolectric tomography) soil analysis are being prepared.

Further geo-engineering and reconstructive measures are urgently required.
