## MONASTERY OF HOSSIOS LUCKAS

### Engineering geological conditions and problem:

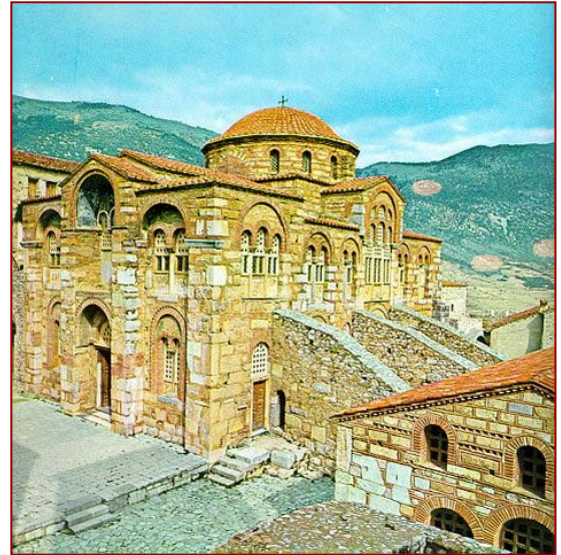
- The monastery lies on the west slope of Mt. Helikon, below the acropolis of ancient Steirion. It was built

during the 10-11th c. AD.

- Weathering of building stones
- Weathering and damage of marble columns
- Stability problems of the monuments
- Landslide phenomena
- Damage of frescos and icons
- Fractures on the walls

- A conservation research was performed in the frame of a EU program, during 1995 (GSRT-GR-EPET II)
- Characterisation of stones
- Estimation of the depth of damage using ultrasonic techniques
- Determination of the treatment effectiveness by measuring the increase of the compressive strength and the ultrasonic velocity of the treated specimens
- Conservation of building stones and mortars
- Stabilization of the monument
- Conservation of frescos
- Slope stability analysis
