Historic centre of Florence

Engineering geological conditions and problems:

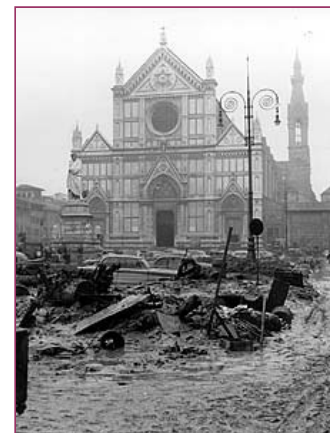
Santa Croce church and square after the 1966 flood (www.weekendafirenze.com)

In 1966, the Arno River flooded the historical centre and several cultural important monuments as Uffizzi, the Santa Croce square and church, the Cathedral square and all the buildings along both sides of the river. *Ponte Vecchio*, the oldest bridge on the river, was partially destroyed.

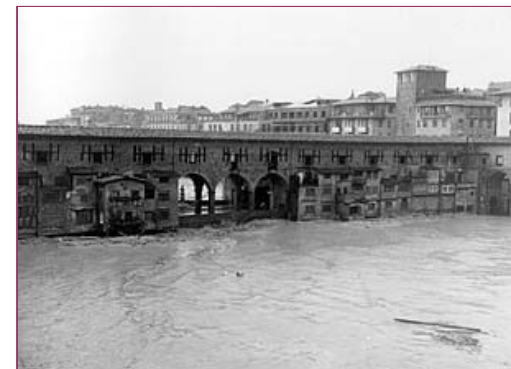
Ponte Vecchio during the 1966 flood (www.mega.it)
