Piazza Armerina, Villa del Casale

Historical background - Engineering geological conditions and problems:

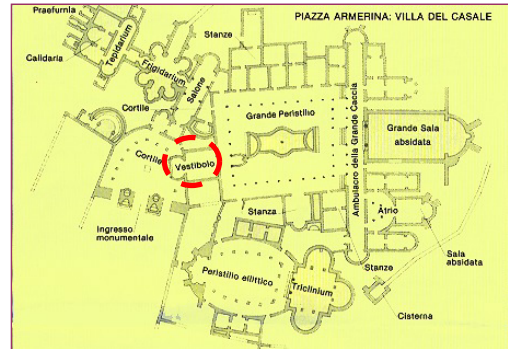
Villa del Casale map (in the red circle the area involved in the last flood)

During the last flood, part of the residence was involved (see the first image).
