LANDSLIDE IN NACHTERSTEDT OF GERMANY

Moraiti E.¹, Christaras B.² & Brauer R.³

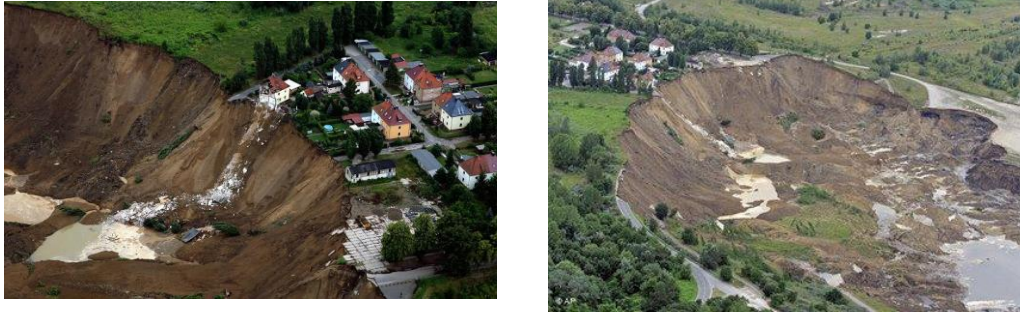
Fig. 1. The landslide of July 19, 2009, in Nachterstedt (Petley, 2009, <http://daveslandslideblog.blogspot.com/>)

On July, 18, 2009, an important landslide created at coastal part of Nachterstedt City toward to Concordia Lake. Three people were died and a privet two-floor house was destroyed together with a big building (Fig.1). The sliding was related to existence of a coal mine under the city. On Feb. 2, 1959, a similar landslide, of 5.8 million m³, had also activated by the coal mine works. One min worker died and many reactions were activated, in the East Germany of that period, regarding to the coal mine exploitation method used.
