HERITAGE
& RISK

Cultural HERITAGE Protection in Times of RISK Challenges and Opportunities

RISKS OF CULTURAL WOODEN INTERIOR ELEMENTS IN OLD BUILDINGS AND CHURCHES IN MACEDONIA, GREECE

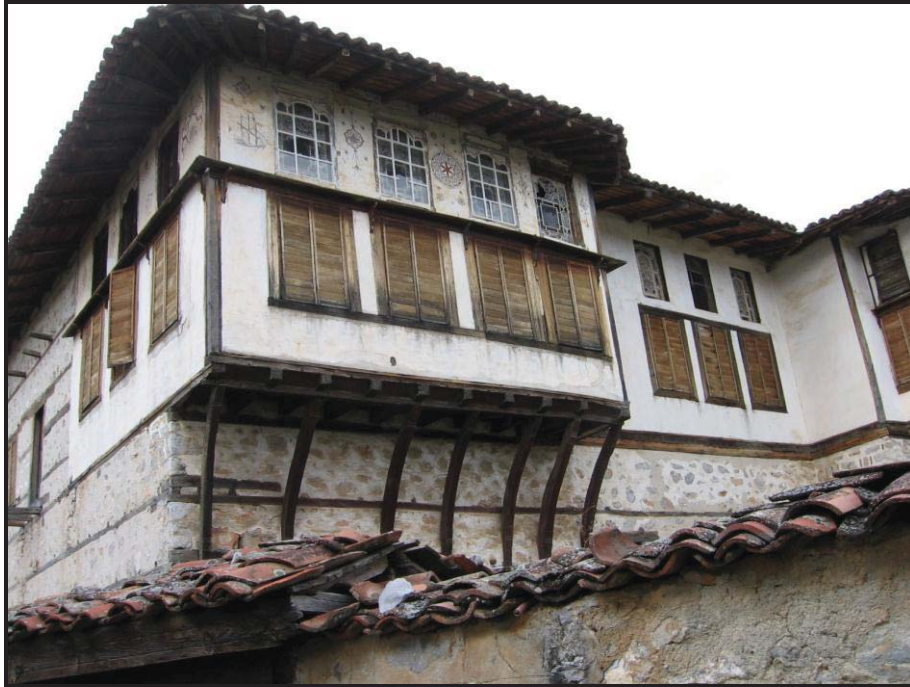
Figure 1. Preservative mansion as museum (Siatista 2010)

mansions have been recognized as national monuments and part of the cultural heritage. Within these settlements some of the mansions have been turned to museums (Figure1) after their restoration and they have conserved most of their wooden decoration. Another small number of them have been turned to hotels and residence of their owners but the great majority of them have been abandoned by their owners to the final collapse.

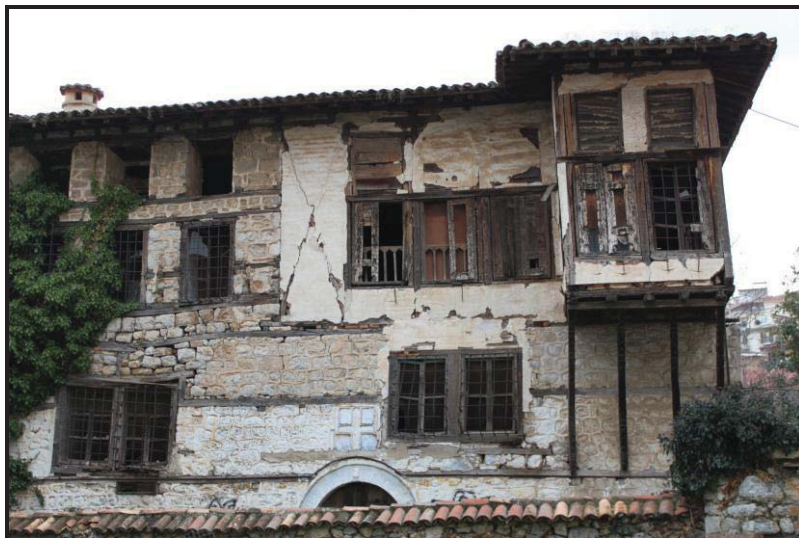
Figure 2. Stone and wood abandoned mansion with sachnisi (projecting porch) (Kastoria, 2010)

According to the Greek law only when a preservative mansion throw down to ruins could his owner to built a new house in the same position (Figure 2). So, because of such a bad low status hundreds of mansions in many villages and settlements through the whole Macedonia are without any serious protection. Following the bad luck of the old buildings their wooden decoration parts are destroyed every day (Figure 3). The only real effort to change this bad situation is carried out by some local Cultural Societies and Unions of active and sensitive citizens.

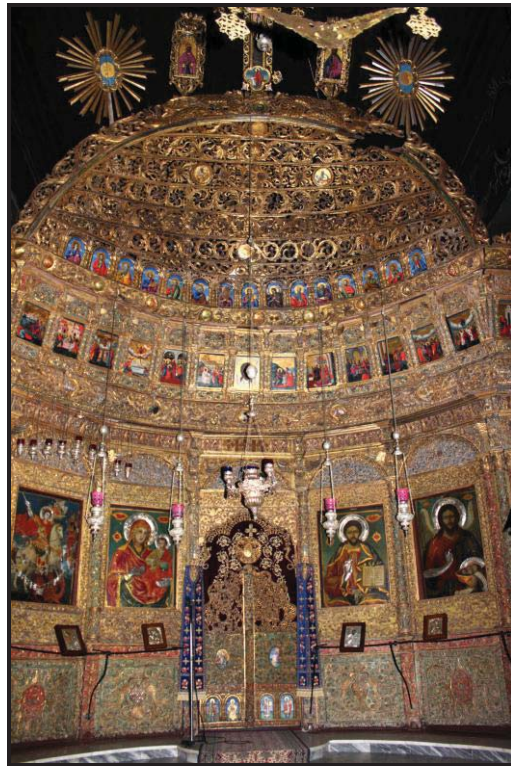
Figure 4. Wooden curved temple (Kozani, 2011)

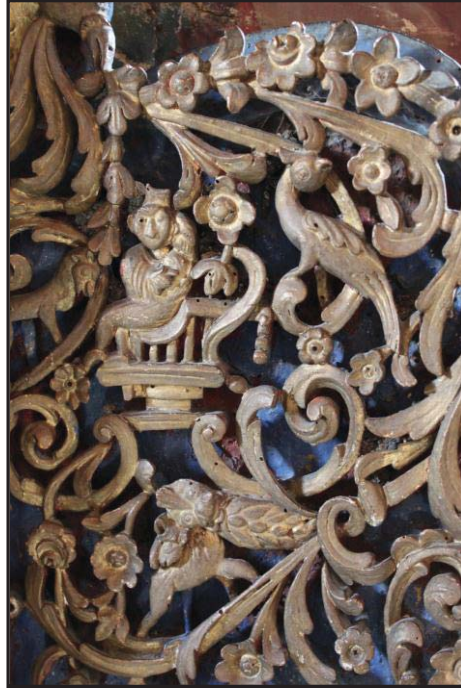
Figure 5. Details from a wood curved door (Vimothiro) (Sidirokastro, 2009)

Some of these churches, mainly the older ones with the most interesting wood carved decorations have been transferred under a special status of protection and restoration (Photo 4). Apart from the few churches which officially declared as monuments there are too many others with equally interesting wooden decorations still remaining unprotected. Even though, they represent unique local cultural heritage remainings of the region, mainly of the early 19th century, they have abandoned to collapse (Figure 5). Some of these churches open once a year to accept visitors (Figure 7).

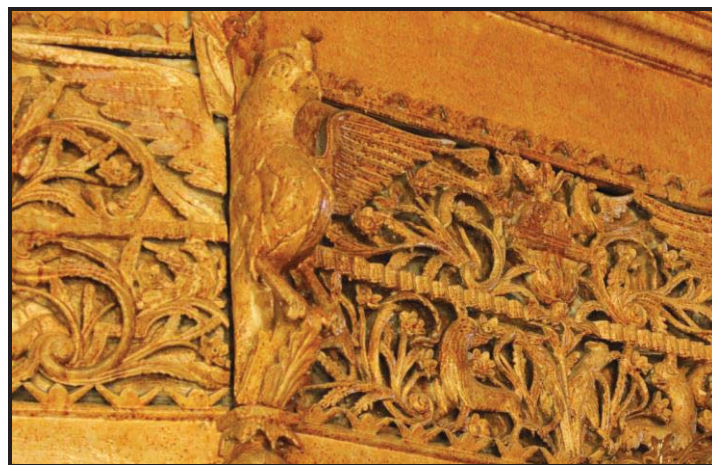
In some settlements, new churches have been constructed where the wooden decoration (temple and other items) from an old and abandoned church have been used. Normally, conservation and restoration of the wooden decoration of these churches never carried out. The most usual conservation treatment that is applied to wooden curved artifacts is the oil painting which actually destroy the artifact by disappearing all of its details (Figure 6).

Figure 6. Overlay wood curving by oil painting (Drama, 2012)
